Evergreen Elementary School

Three Rivers/Josephine County SD

FEMA 154 Rapid Visual Screening Score Card

Rapid Visual Screening - Senate Bill #2 - Seismic Needs Assessment
Oregon Department of Geology and Mineral Industries

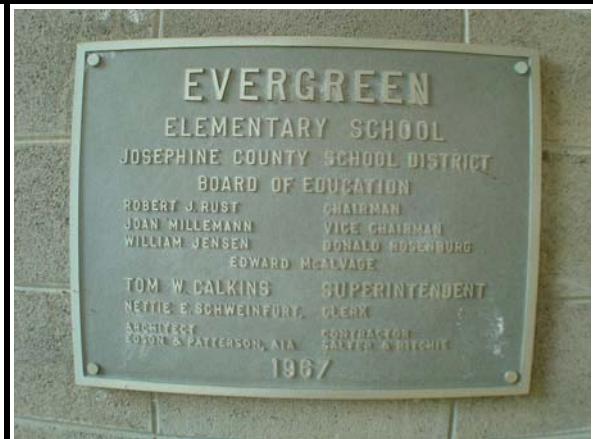
Jose_sch07A

Type	Basic Score	Vert Irreg	Plan Irreg	Pre-Code	Post-Bench	Soil C	Soil D	Soil E	RVS Score
Primary	RM1	2.8	0	0	0	0	0	-0.6	0	2.2
Secondary		0	0	0	0	0	0	0	0	0
Tertiary		0	0	0	0	0	0	0	0	0

Final Type	Final Score
RM1	2.2

Low (<1%)

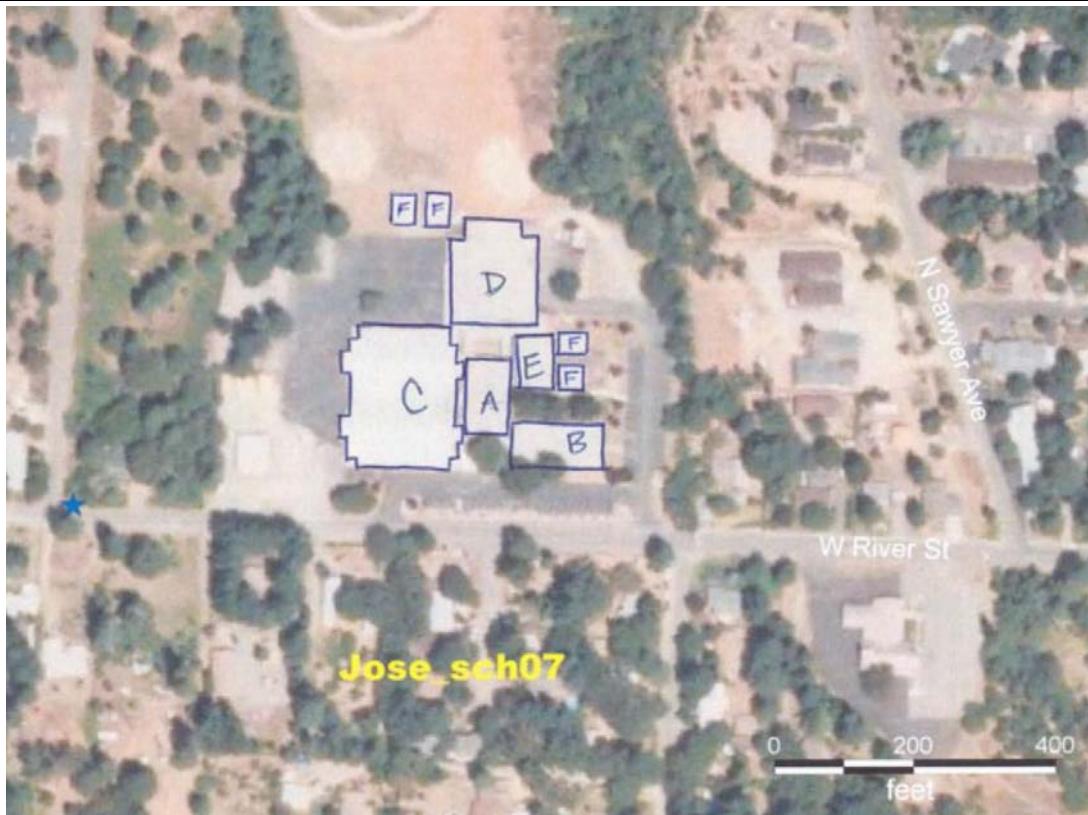
Enrollment 469	Year Built (Field Verified) 1967	Year Built (Alt. Source) 1967	Est. Decade Built 1960
Total Area (square ft) 59342	Number of Stories 1	Basement	Pounding Potential No
Plan Irregularities None None None		Vertical Irregularities None None None	
Falling Hazards None None None		Poor Conditions None None None

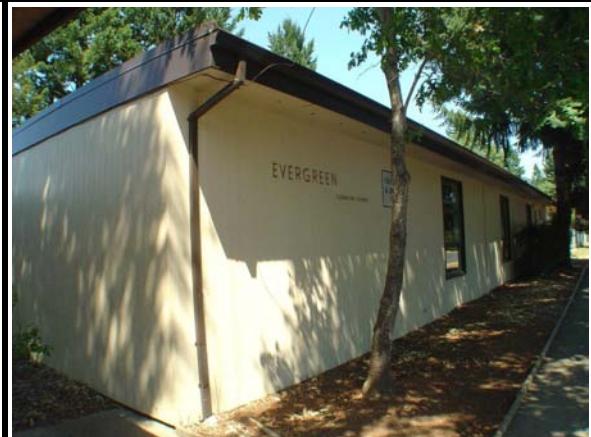
Jose_sch07B

Type	Basic Score	Vert Irreg	Plan Irreg	Pre-Code	Post-Bench	Soil C	Soil D	Soil E	RVS Score
Primary	W2	3.8	0	0	0	0	0	-0.8	0	3
Secondary		0	0	0	0	0	0	0	0	0
Tertiary		0	0	0	0	0	0	0	0	0

Final Type	Final Score
W2	3

Low (<1%)

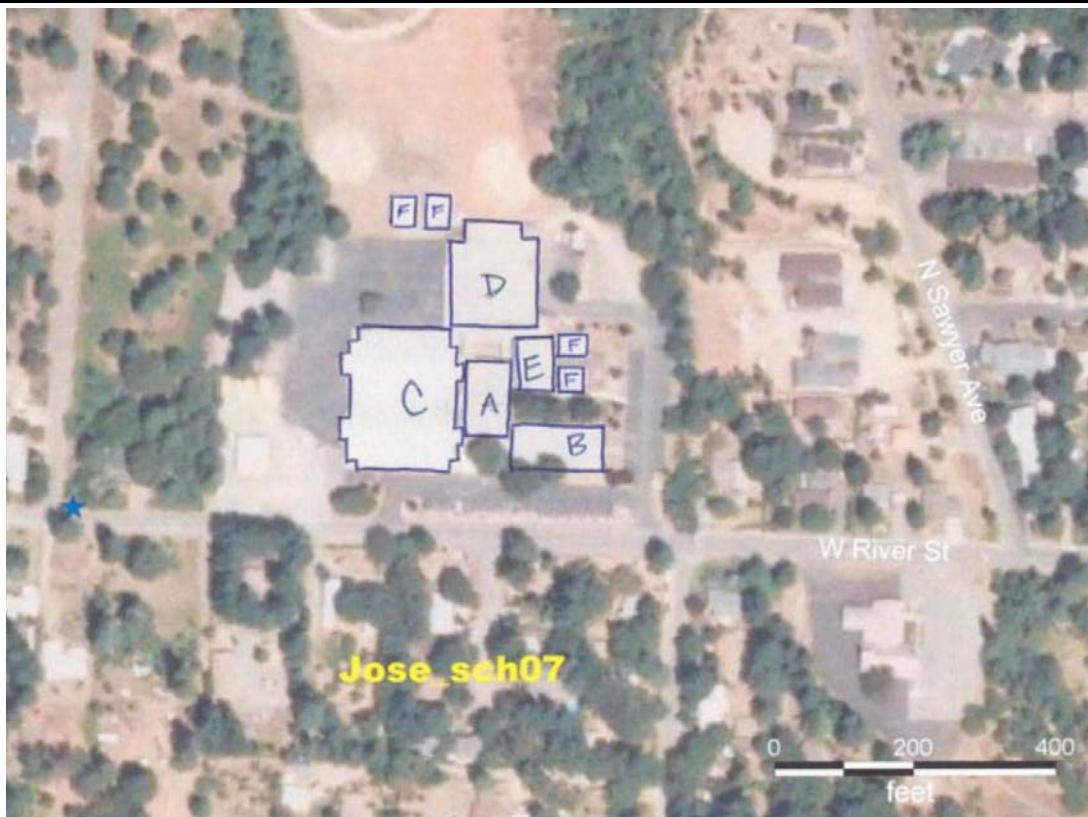
Enrollment 469	Year Built (Field Verified) 1967	Year Built (Alt. Source) 1967	Est. Decade Built 1960
Total Area (square ft) 59342	Number of Stories 1	Basement	Pounding Potential No
Plan Irregularities None None None		Vertical Irregularities None None None	
Falling Hazards None None None		Poor Conditions None None None

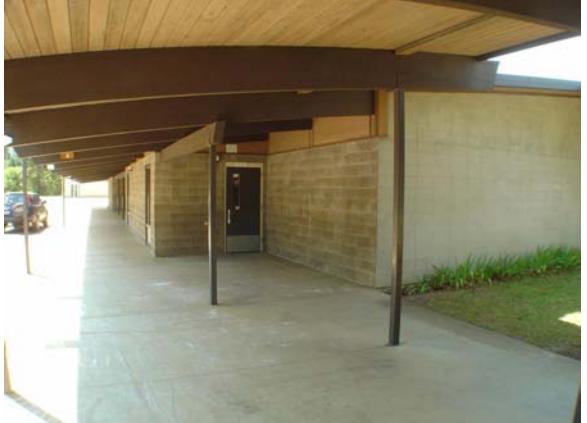
Jose_sch07C

Type	Basic Score	Vert Irreg	Plan Irreg	Pre-Code	Post-Bench	Soil C	Soil D	Soil E	RVS Score
Primary	RM1	2.8	0	-0.5	0	0	0	-0.6	0	1.7
Secondary		0	0	0	0	0	0	0	0	0
Tertiary		0	0	0	0	0	0	0	0	0

Final Type	Final Score
RM1	1.7

Moderate (>1%)

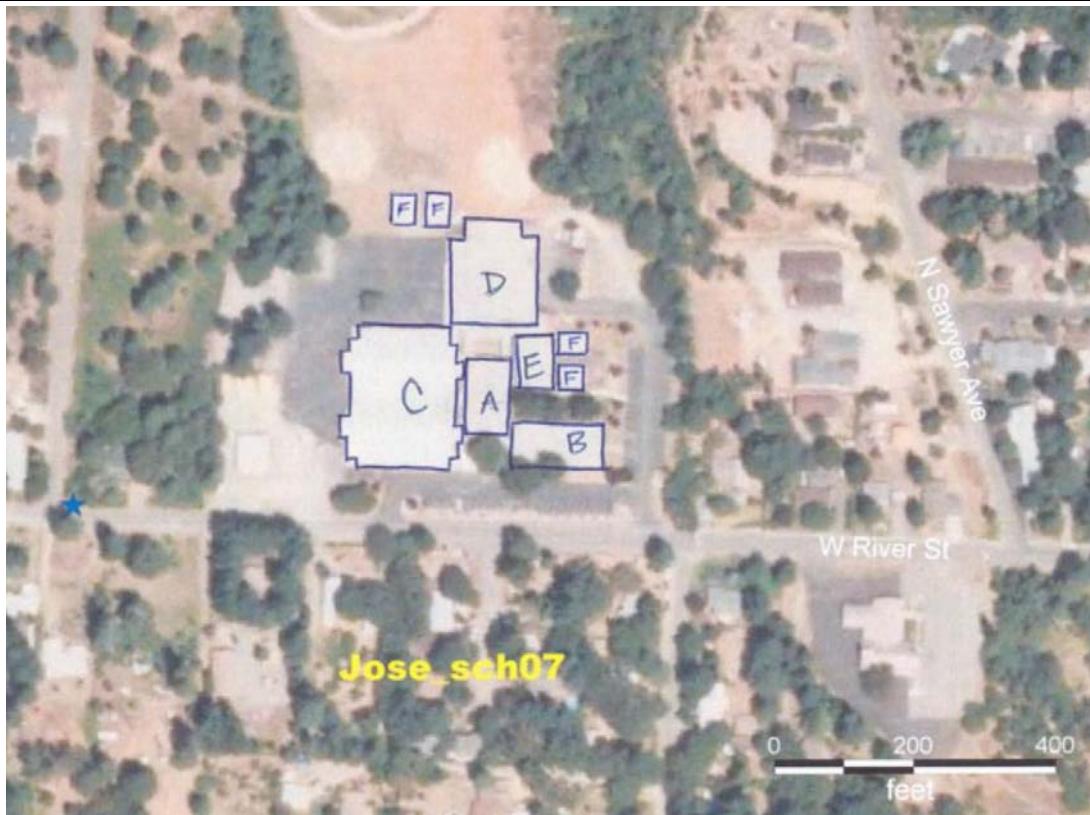
Enrollment 469	Year Built (Field Verified) 1967	Year Built (Alt. Source) 1967	Est. Decade Built 1960
Total Area (square ft) 59342	Number of Stories 1	Basement	Pounding Potential No
Plan Irregularities Out of Plane Lateral-Force-Resistance Elements None None		Vertical Irregularities None None None	
Falling Hazards None None None		Poor Conditions None None None

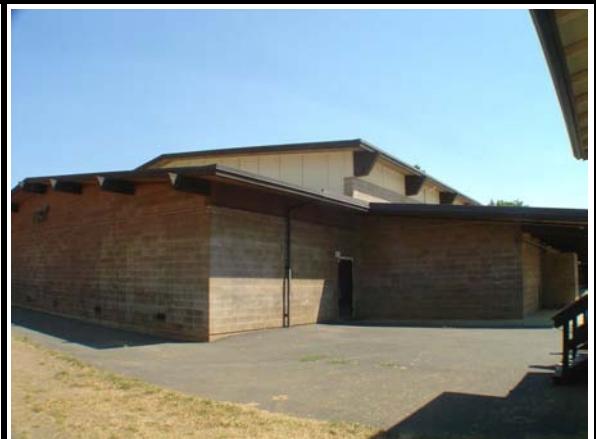
Jose_sch07D

Type	Basic Score	Vert Irreg	Plan Irreg	Pre-Code	Post-Bench	Soil C	Soil D	Soil E	RVS Score
Primary	RM1	2.8	-1	-0.5	0	0	0	-0.6	0	0.7
Secondary		0	0	0	0	0	0	0	0	0
Tertiary		0	0	0	0	0	0	0	0	0

Final Type	Final Score
RM1	0.7

High (>10%)

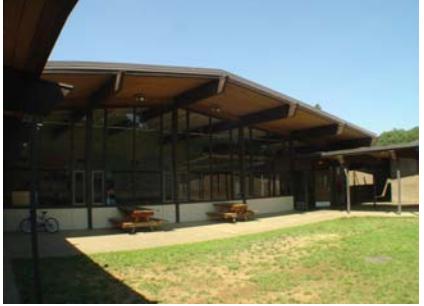
S General Site

Enrollment 469	Year Built (Field Verified) 1967	Year Built (Alt. Source) 1960	Est. Decade Built 1960
Total Area (square ft) 59342	Number of Stories 1	Basement	Pounding Potential No
Plan Irregularities Reentrant Corners: Other None None		Vertical Irregularities Steps in Elevation View: Single Change None None	
Falling Hazards None None None		Poor Conditions None None None

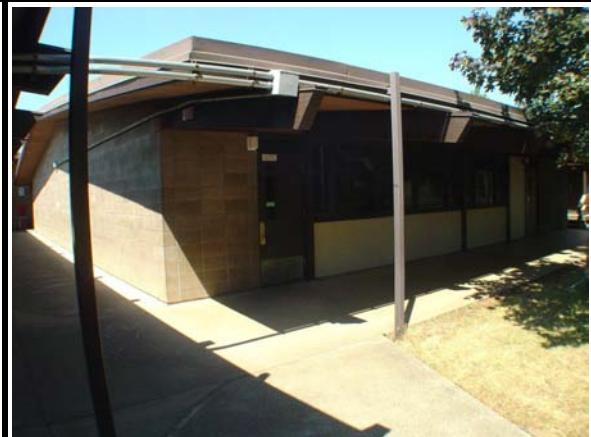
Jose_sch07E

Type	Basic Score	Vert Irreg	Plan Irreg	Pre-Code	Post-Bench	Soil C	Soil D	Soil E	RVS Score
Primary	RM1	2.8	0	0	0	0	0	-0.6	0	2.2
Secondary		0	0	0	0	0	0	0	0	0
Tertiary		0	0	0	0	0	0	0	0	0

Final Type	Final Score
RM1	2.2

Low (<1%)
