Jerome Prairie Elementary School

Three Rivers/Josephine County SD

FEMA 154 Rapid Visual Screening Score Card

Rapid Visual Screening - Senate Bill #2 - Seismic Needs Assessment
Oregon Department of Geology and Mineral Industries

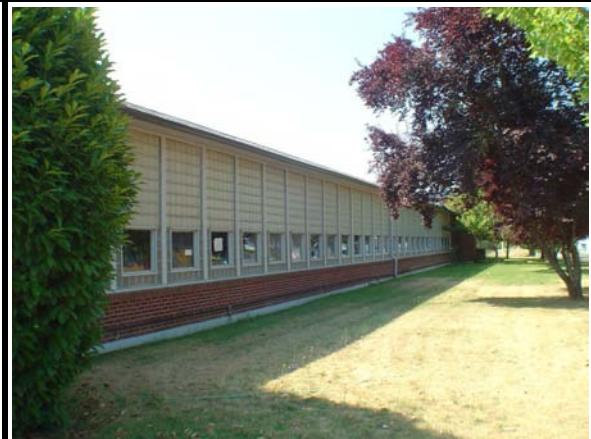
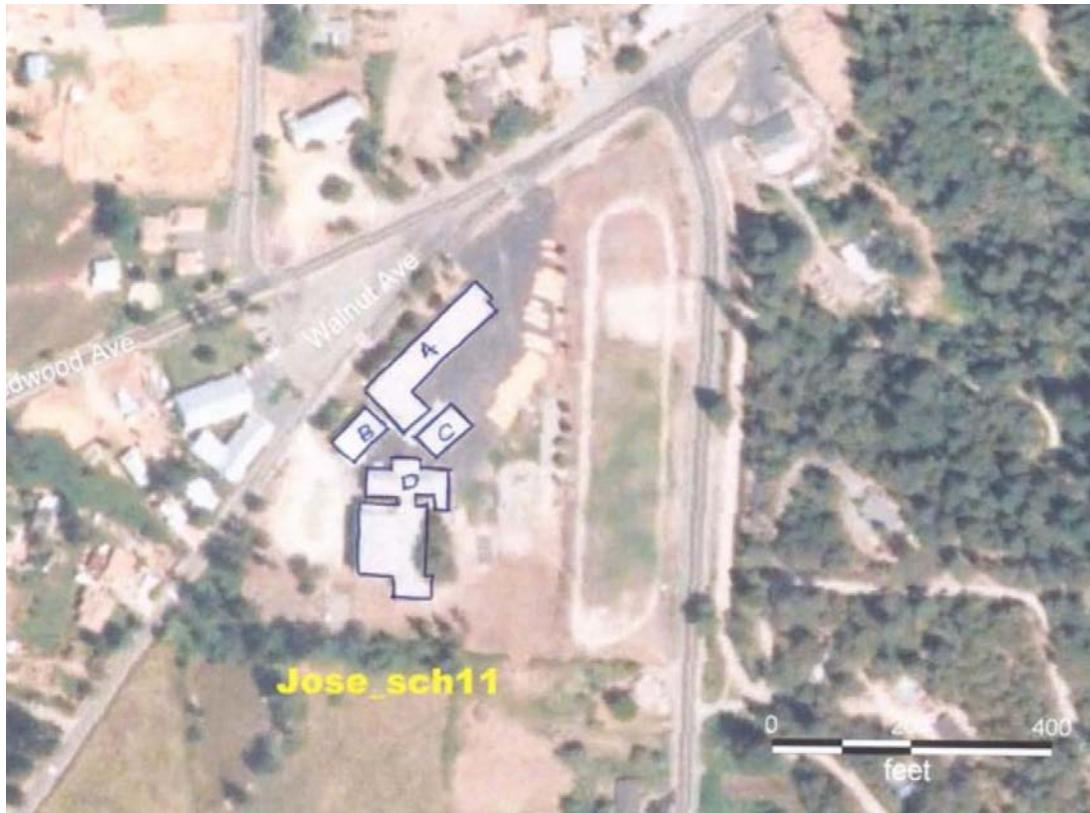
Jose_sch11A

Type	Basic Score	Vert Irreg	Plan Irreg	Pre-Code	Post-Bench	Soil C	Soil D	Soil E	RVS Score
Primary	W2	3.8	0	-0.5	-1	0	0	0	0	2.3
Secondary	RM1	2.8	0	-0.5	-1	0	0	0	0	1.3
Tertiary		0	0	0	0	0	0	0	0	0

Final Type	Final Score
RM1	1.3

Moderate (>1%)

Enrollment 256	Year Built (Field Verified) 1938	Year Built (Alt. Source) 1938	Est. Decade Built 1930
Total Area (square ft) 30838	Number of Stories 1	Basement	Pounding Potential No
Plan Irregularities		Vertical Irregularities	
Reentrant Corners: L Shaped		None	
Out of Plane Lateral-Force-Resistance Elements		None	
None		None	
Falling Hazards		Poor Conditions	
Unreinforced Chimneys		None	
None		None	
None		None

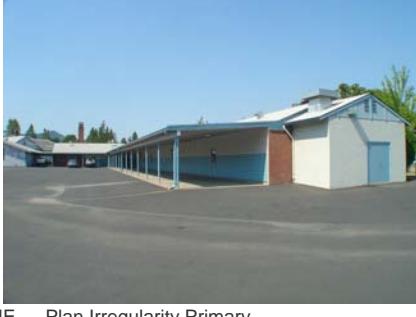
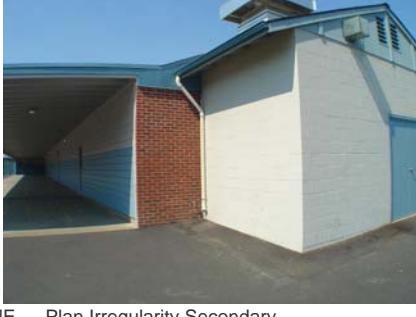
NE Plan Irregularity Primary		NE Plan Irregularity Secondary Secondary structural type can also be seen.	
		S Falling Hazard

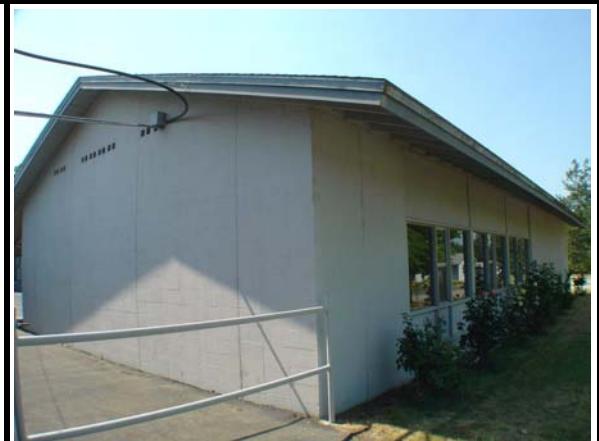
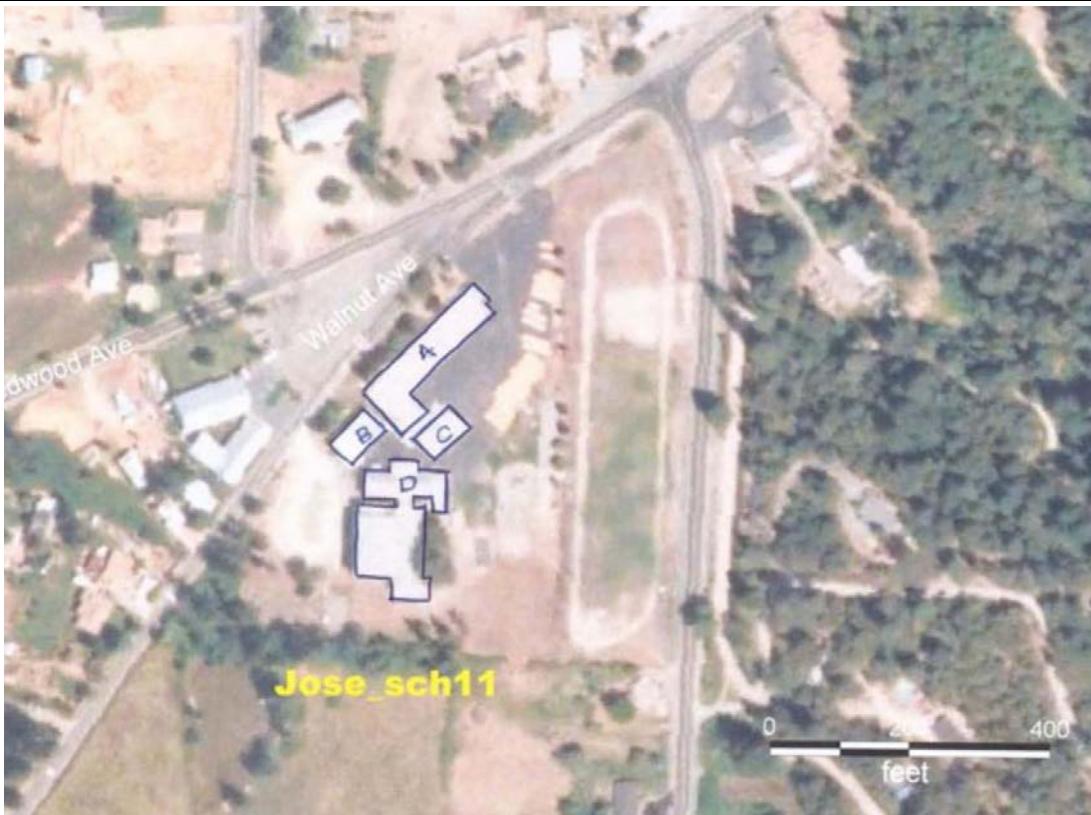
Jose_sch11B

Type	Basic Score	Vert Irreg	Plan Irreg	Pre-Code	Post-Bench	Soil C	Soil D	Soil E	RVS Score
Primary	RM1	2.8	0	0	0	0	0	0	0	2.8
Secondary		0	0	0	0	0	0	0	0	0
Tertiary		0	0	0	0	0	0	0	0	0

Final Type	Final Score
RM1	2.8

Low (<1%)

Enrollment 256	Year Built (Field Verified) 1938	Year Built (Alt. Source) 1938	Est. Decade Built 1950
Total Area (square ft) 30838	Number of Stories 1	Basement	Pounding Potential No
Plan Irregularities None None None		Vertical Irregularities None None None	
Falling Hazards None None None		Poor Conditions None None None

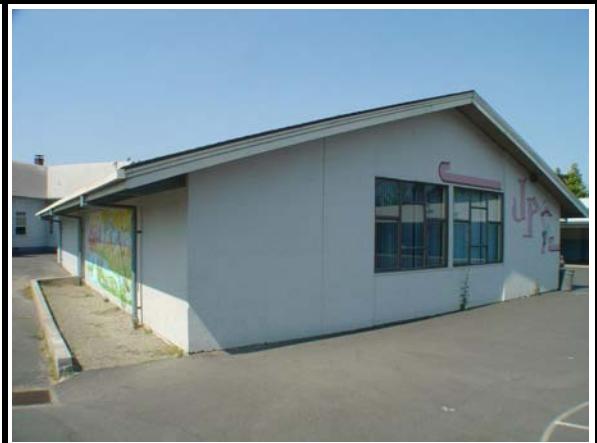
Jose_sch11C

Type	Basic Score	Vert Irreg	Plan Irreg	Pre-Code	Post-Bench	Soil C	Soil D	Soil E	RVS Score
Primary	RM1	2.8	0	0	0	0	0	0	0	2.8
Secondary		0	0	0	0	0	0	0	0	0
Tertiary		0	0	0	0	0	0	0	0	0

Final Type	Final Score
RM1	2.8

Low (<1%)

Enrollment 256	Year Built (Field Verified) 1938	Year Built (Alt. Source) 1938	Est. Decade Built 1950
Total Area (square ft) 30838	Number of Stories 1	Basement No	Pounding Potential No
Plan Irregularities None None None		Vertical Irregularities None None None	
Falling Hazards None None None		Poor Conditions None None None

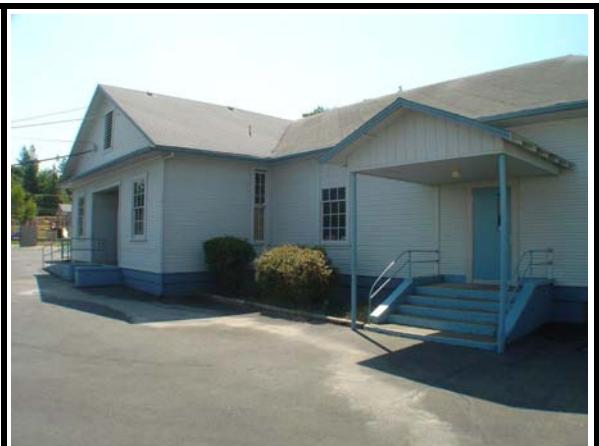
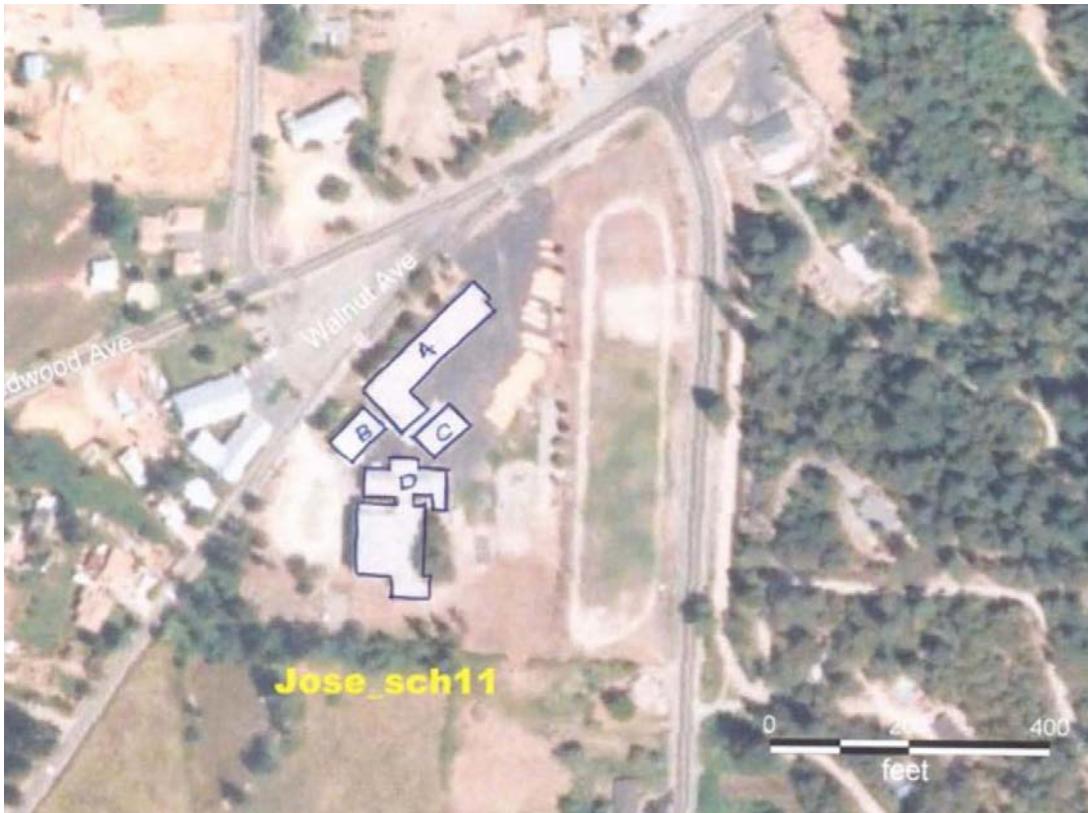
Jose_sch11D

Type	Basic Score	Vert Irreg	Plan Irreg	Pre-Code	Post-Bench	Soil C	Soil D	Soil E	RVS Score
Primary	W2	3.8	-2	-0.5	-1	0	0	0	0	0.3
Secondary		0	0	0	0	0	0	0	0	0
Tertiary		0	0	0	0	0	0	0	0	0

Final Type	Final Score
W2	0.3

High (>10%)

Enrollment 256	Year Built (Field Verified) 1938	Year Built (Alt. Source) 1930	Est. Decade Built 1930
Total Area (square ft) 30838	Number of Stories 1	Basement	Pounding Potential Yes
Plan Irregularities		Vertical Irregularities	
Reentrant Corners: Other		Steps in Elevation View: 2 to 3 Changes	
Out of Plane Lateral-Force-Resistance Elements		None	
None		None	
Falling Hazards		Poor Conditions	
Unreinforced Chimneys		None	
None		None	
None		None

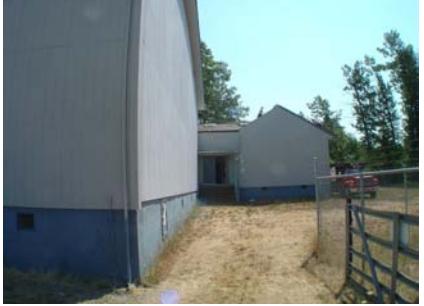
W Plan Irregularity Primary

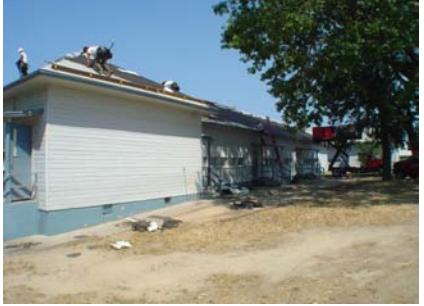
E General Site
New roof.

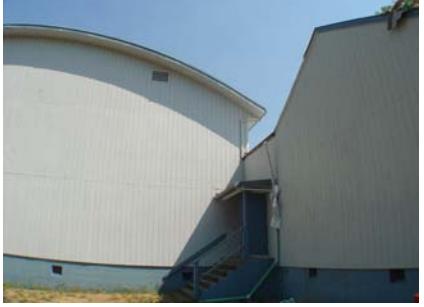
S Vertical Irregularity Primary
