Allen Dale Elementary School

Jose_sch20A

FEMA 154 Rapid Visual Screening Score Card

Rapid Visual Screening - Senate Bill #2 - Seismic Needs Assessment
Oregon Department of Geology and Mineral Industries

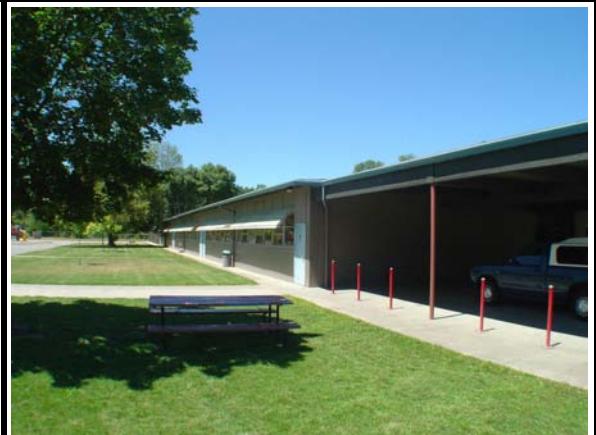
Building Type	County		
School	Josephine		
Street			
2320 Williams Hwy			
City	State	Zip	
Grants Pass	OR	97527	
Latitude	Longitude		
42.41058	123.34845		
Tracking Code	Inspection Date		
RVS in 2006	7/19/2006

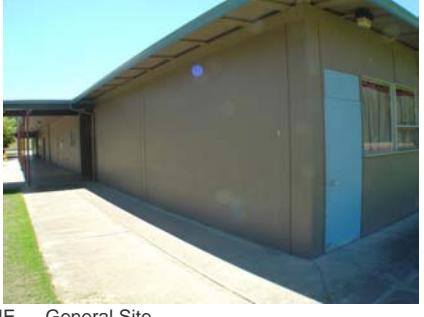
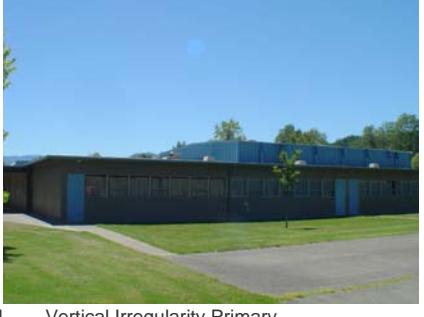
Enrollment 487	Year Built (Field Verified) 1961	Year Built (Alt. Source) 1961	Est. Decade Built 1960
Total Area (square ft) 48829	Number of Stories 1	Basement	Pounding Potential No
Plan Irregularities		Vertical Irregularities	
Reentrant Corners: Other		Steps in Elevation View: Single Change	
Reentrant Corners: Other		None	
None		None	
Falling Hazards		Poor Conditions	
None		None	
None		None	
None		None

NE General Site	N Vertical Irregularity Primary	W Plan Irregularity Primary

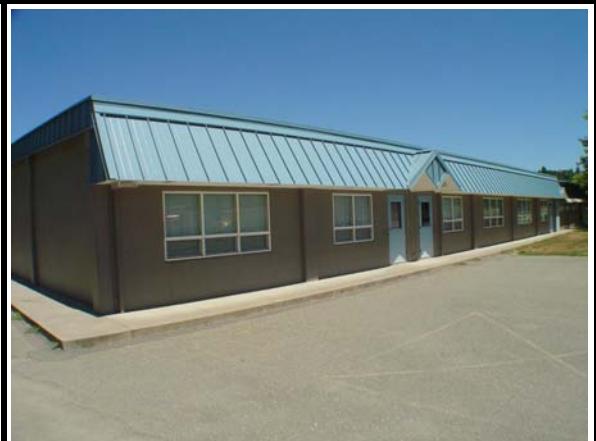
Jose_sch20B

Building Type	County	
School	Josephine	
Street		
2320 Williams Hwy		
City	State	Zip
Grants Pass	OR	97527
Latitude	Longitude	
42.41043	123.34889	
Tracking Code	Inspection Date	
RVS in 2006	7/19/2006
