# Chiloquin Agency Lake Fire District

Klam\_fir05A

## FEMA 154 Rapid Visual Screening Score Card

Rapid Visual Screening - Senate Bill #2 - Seismic Needs Assessment  
Oregon Department of Geology and Mineral Industries

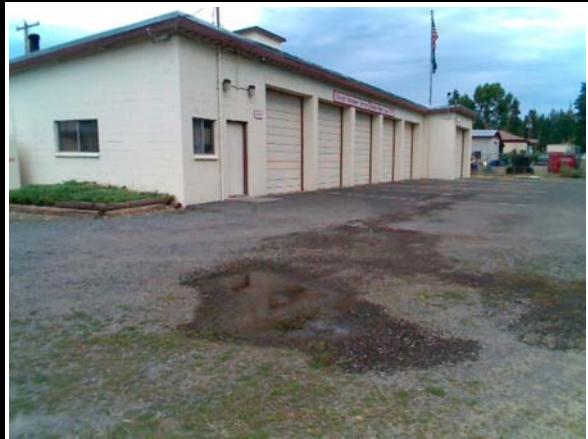
Building Type Fire - RFPD	County Klamath	
Street 156 S 2nd Ave		
City Chiloquin	State OR	Zip 97624
Latitude 42.57536	Longitude 121.86273	
Tracking Code RVS in 2006	Inspection Date 7/21/2006

Type	Basic Score	Vert Irreg	Plan Irreg	Pre-Code	Post-Bench	Soil C	Soil D	Soil E	RVS Score
Primary	RM1	3.6	-2	-0.5	0	0	0	-1.2	0	-0.1
Secondary		0	0	0	0	0	0	0	0	0
Tertiary		0	0	0	0	0	0	0	0	0

Final Type	Final Score
RM1	-0.1

Very High (100%)

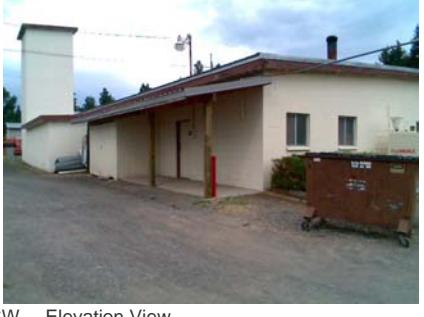
SW Elevation View

Enrollment	Year Built (Field Verified)	Year Built (Alt. Source)	Est. Decade Built
			1960
Total Area (square ft)	Number of Stories	Basement	Pounding Potential
	1	No	No
Plan Irregularities		Vertical Irregularities	
Reentrant Corners: Other		Steps in Elevation View: Single Change	
Torsion: Eccentric Stiffness		None	
None		None	
Falling Hazards		Poor Conditions	
None		None	
None		None	
None		None
