# Chiloquin Agency Lake Fire District

## FEMA 154 Rapid Visual Screening Score Card

Rapid Visual Screening - Senate Bill #2 - Seismic Needs Assessment  
Oregon Department of Geology and Mineral Industries

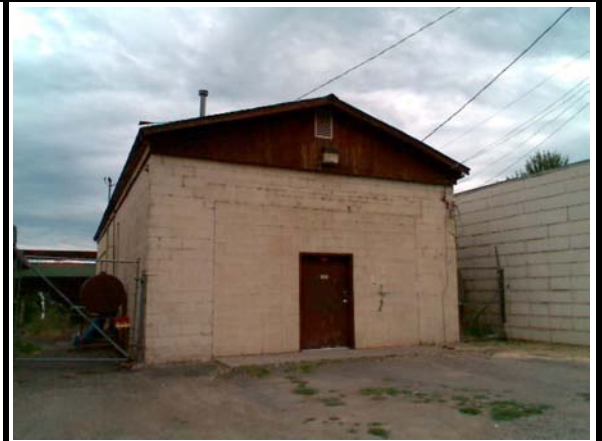
Seismicity Zone: Moderate

| | Type | Basic Score | Vert Irreg | Plan Irreg | Pre-Code | Post-Bench | Soil C | Soil D | Soil E | RVS Score |
|---|---|---|---|---|---|---|---|---|---|---|
| Primary | RM1 | 3.6 | 0 | 0 | 0 | 0 | 0 | -1.2 | 0 | 2.4 |

RM1

2.4

Low (<1%)
