Harriman RFPD

Building Type Fire - RFPD	County Klamath	
Street 25600 Rocy Point Rd.		
City Klamath Falls	State OR	Zip 97601
Latitude 42.45956	Longitude 122.10627	
Tracking Code RVS in 2006	Inspection Date 7/20/2006

FEMA 154 Rapid Visual Screening Score Card

Rapid Visual Screening - Senate Bill #2 - Seismic Needs Assessment
Oregon Department of Geology and Mineral Industries

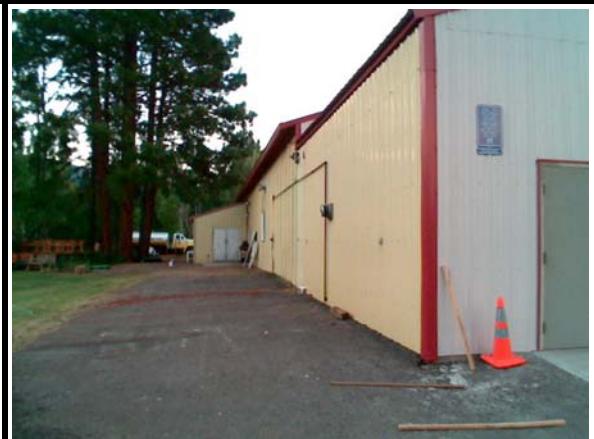
Seismicity Zone: High

Type	Basic Score	Vert Irreg	Plan Irreg	Pre-Code	Post-Bench	Soil C	Soil D	Soil E	RVS Score
Primary	S3	3.2	0	-0.5	0	0	0	-0.6	0	2.1
Secondary	W1	4.4	-2.5	-0.5	0	2.4	0	0	0	3.8
Tertiary	RM1	2.8	-1	-0.5	0	0	0	-0.6	0	0.7

Final Type	Final Score
RM1	0.7

High (>10%)

Enrollment	Year Built (Field Verified)	Year Built (Alt. Source)	Est. Decade Built
			1980
Total Area (square ft)	Number of Stories	Basement	Pounding Potential
	1	No	No
Plan Irregularities		Vertical Irregularities	
Reentrant Corners: L Shaped		Steps in Elevation View: Single Change	
None		None	
None		None	
Falling Hazards		Poor Conditions	
None		None	
None		None	
None		None

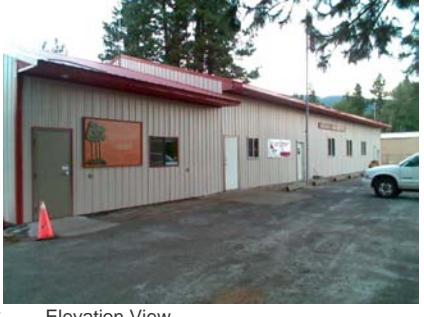
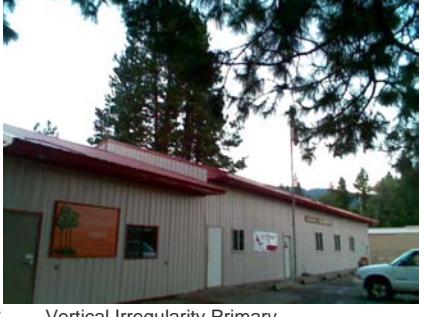
S	Elevation View	S	Vertical Irregularity Primary
