Bly RFPD

FEMA 154 Rapid Visual Screening Score Card

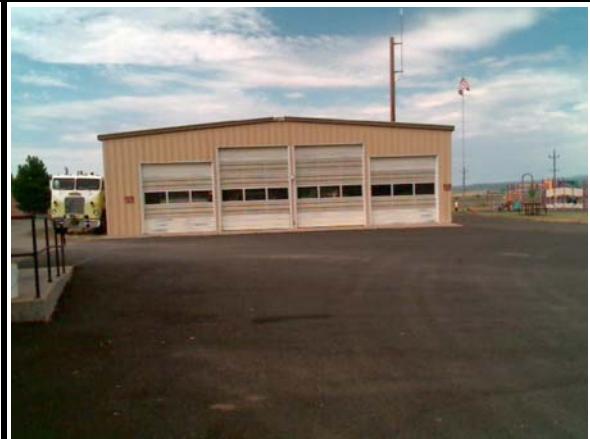
Type	Basic Score	Vert Irreg	Plan Irreg	Pre-Code	Post-Bench	Soil C	Soil D	Soil E	RVS Score
Primary	S3	3.8	0	-0.5	0	0	0	0	0	3.3
Secondary		0	0	0	0	0	0	0	0	0
Tertiary		0	0	0	0	0	0	0	0	0

Final Type	Final Score
S3	3.3

Low (<1%)

Enrollment	Year Built (Field Verified)	Year Built (Alt. Source)	Est. Decade Built
			1980
Total Area (square ft)	Number of Stories	Basement	Pounding Potential
	1	No	No
Plan Irregularities		Vertical Irregularities	
Torsion: Eccentric Stiffness		None	
None		None	
None		None	
Falling Hazards		Poor Conditions	
None		None	
None		None	
None		None

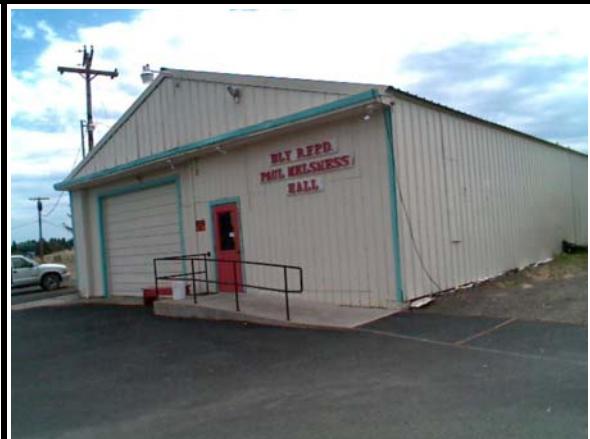
Type	Basic Score	Vert Irreg	Plan Irreg	Pre-Code	Post-Bench	Soil C	Soil D	Soil E	RVS Score
Primary	W1	5.2	0	0	0	0	0	0	0	5.2
Secondary	S3	3.8	0	0	0	0	0	0	0	3.8
Tertiary	RM1	3.6	0	0	0	0	0	0	0	3.6

Final Type	Final Score
RM1	3.6

Low (<1%)

Enrollment	Year Built (Field Verified)	Year Built (Alt. Source)	Est. Decade Built
			1960
Total Area (square ft)	Number of Stories	Basement	Pounding Potential
	1	No	No
Plan Irregularities		Vertical Irregularities	
None		None	
None		None	
None		None	
Falling Hazards		Poor Conditions	
None		None	
None		None	
None		None
