Klamath County Sheriff's Office

Klam_pol01A

FEMA 154 Rapid Visual Screening Score Card

Rapid Visual Screening - Senate Bill #2 - Seismic Needs Assessment
Oregon Department of Geology and Mineral Industries

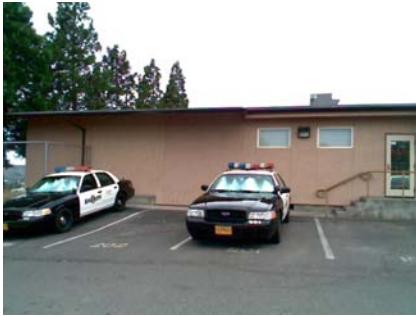
S	General Site	S	Primary Structural Type

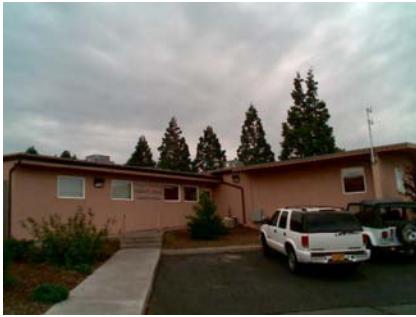
Enrollment	Year Built (Field Verified)	Year Built (Alt. Source)	Est. Decade Built
			1980
Total Area (square ft)	Number of Stories	Basement	Pounding Potential
	1	No	No
Plan Irregularities		Vertical Irregularities	
Reentrant Corners: L Shaped		Steps in Elevation View: Single Change	
None		None	
None		None	
Falling Hazards		Poor Conditions	
None		None	
None		None	
None		None

NW	Plan Irregularity Primary	NW	Vertical Irregularity Primary
