Building Type	County
School	Klamath
Street	
300 Elm St	
City	State Zip
Chiloquin	OR 97624
Latitude	Longitude
42.56753	121.86341
Tracking Code	Inspection Date
Structural Engineering Report	9/15/2006

## FEMA 154 Rapid Visual Screening Score Card

# Chiloquin High School

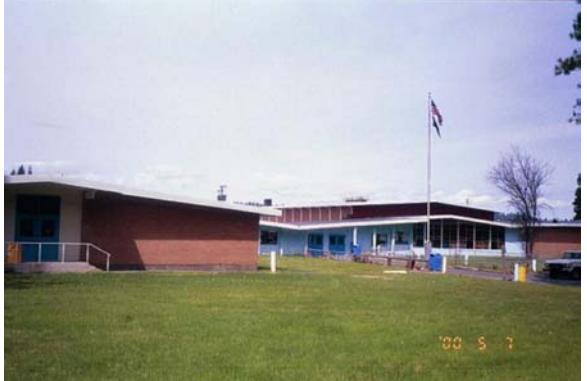
Klam\_sch14A

Final Type	Final Score
RM1	-0.5

Very High (100%)

Enrollment 282	Year Built (Field Verified) 1937	Year Built (Alt. Source) 1937	Est. Decade Built
Total Area (square ft) 73680	Number of Stories 1	Basement	Pounding Potential No
Plan Irregularities		Vertical Irregularities	
<input type="text"/>		<input type="text"/>	
<input type="text"/>		<input type="text"/>	
<input type="text"/>		<input type="text"/>	
Falling Hazards		Poor Conditions	
<input type="text"/>		<input type="text"/>	
<input type="text"/>		<input type="text"/>	
<input type="text"/>		<input type="text"/>
