FEMA 154 Rapid Visual Screening Score Card

Henley High School

Klam_sch15A

Rapid Visual Screening - Senate Bill #2 - Seismic Needs Assessment
Oregon Department of Geology and Mineral Industries

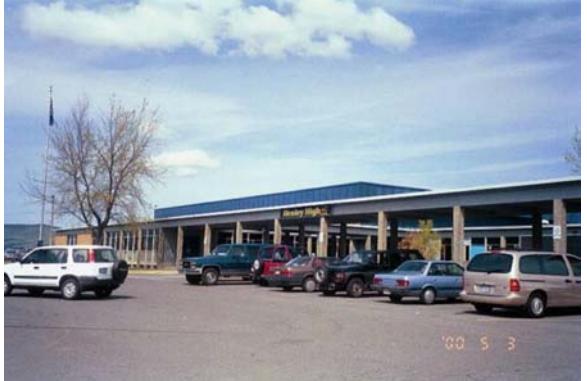
Type	Basic Score	Vert Irreg	Plan Irreg	Pre-Code	Post-Bench	Soil C	Soil D	Soil E	RVS Score
Primary	RM1	2.8	-1	-0.5	0	0	0	-0.6	0	0.7
Secondary		0	0	0	0	0	0	0	0	0
Tertiary		0	0	0	0	0	0	0	0	0

Final Type	Final Score
RM1	0.7

High (>10%)

Enrollment 657	Year Built (Field Verified) 1964	Year Built (Alt. Source) 1964	Est. Decade Built
Total Area (square ft) 121200	Number of Stories 1	Basement	Pounding Potential No
Plan Irregularities		Vertical Irregularities	
Falling Hazards		Poor Conditions
