Lost River High School

FEMA 154 Rapid Visual Screening Score Card

Rapid Visual Screening - Senate Bill #2 - Seismic Needs Assessment
Oregon Department of Geology and Mineral Industries

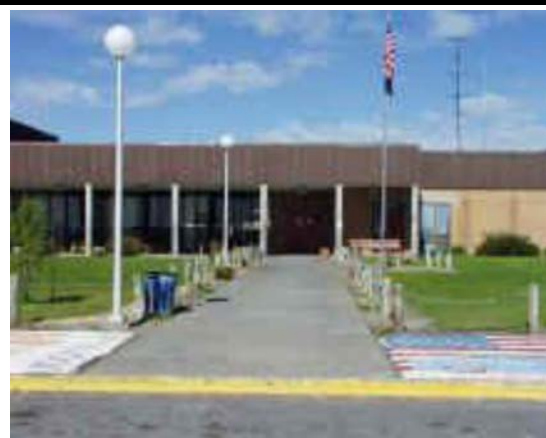
Lost River High School

Type	Basic Score	Vert Irreg	Plan Irreg	Pre-Code	Post-Bench	Soil C	Soil D	Soil E	RVS Score
Primary	RM1	2.8	-1	-0.5	0	0	-0.4	0	0	0.9
Secondary		0	0	0	0	0	0	0	0	0
Tertiary		0	0	0	0	0	0	0	0	0

FEMA-154 Collapse Potential

High (>10%)
