# Paisley VFD

Lake\_fir03A

Rapid Visual Screening - Senate Bill #2 - Seismic Needs Assessment  
Oregon Department of Geology and Mineral Industries

Lake\_fir03B

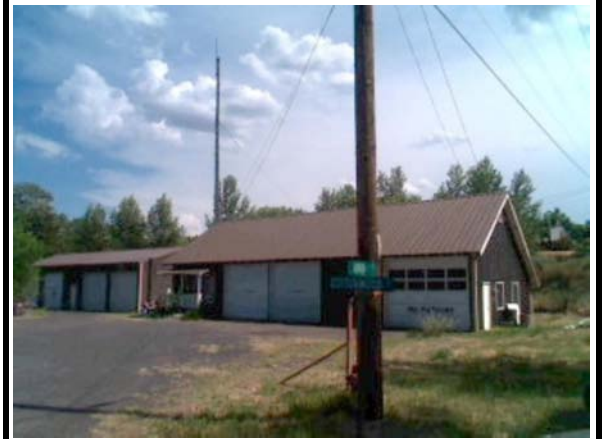
Seismicity Zone: Moderate

| | Type | Basic Score | Vert Irreg | Plan Irreg | Pre-Code | Post-Bench | Soil C | Soil D | Soil E | RVS Score |
|---|---|---|---|---|---|---|---|---|---|---|
| Primary | W1 | 5.2 | 0 | 0 | 0 | 0 | 0 | -0.6 | 0 | 4.6 |

Low (<1%)

| Plan Irregularities | Vertical Irregularities |
| None | None |

| Falling Hazards | Poor Conditions |
| None | None |

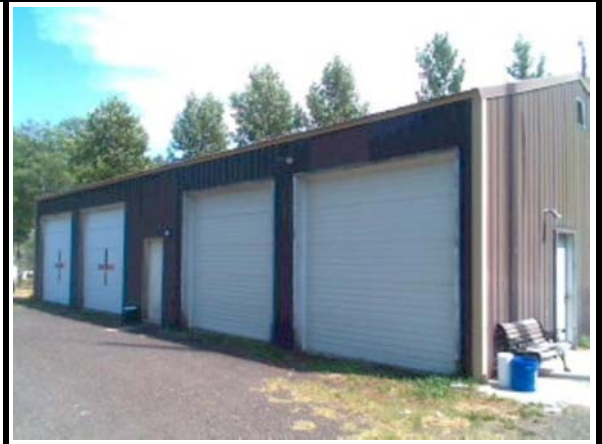
| | Type | Basic Score | Vert Irreg | Plan Irreg | Pre-Code | Post-Bench | Soil C | Soil D | Soil E | RVS Score |
|---|---|---|---|---|---|---|---|---|---|---|
| Primary | W1 | 5.2 | 0 | -0.5 | 0 | 0 | 0 | -0.6 | 0 | 4.1 |

Low (<1%)

| Torsion: Eccentric Stiffness | None |
