# North Lake School

Lake\_sch03A

## FEMA 154 Rapid Visual Screening Score Card

Rapid Visual Screening - Senate Bill #2 - Seismic Needs Assessment  
Oregon Department of Geology and Mineral Industries

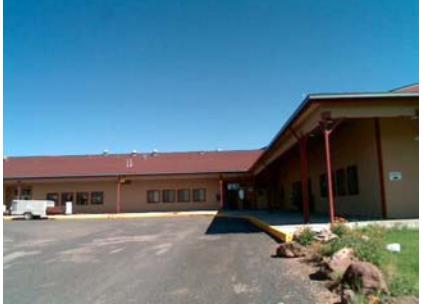
SW General Site

Enrollment 208	Year Built (Field Verified) 1991	Year Built (Alt. Source) 1991	Est. Decade Built 1990
Total Area (square ft) 54000	Number of Stories 1	Basement	Pounding Potential No
Plan Irregularities Reentrant Corners: T shaped Reentrant Corners: L Shaped (Adjacent Build/Entity) None		Vertical Irregularities None None None	
Falling Hazards None None None		Poor Conditions None None None

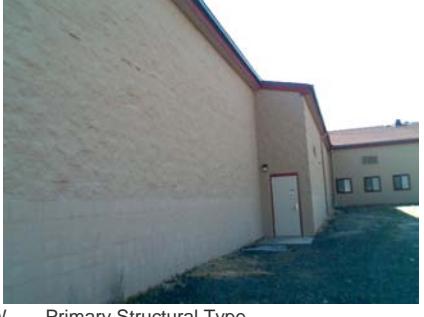
W Primary Structural Type

Enrollment 208	Year Built (Field Verified) 1991	Year Built (Alt. Source) 1991	Est. Decade Built 1990
Total Area (square ft) 54000	Number of Stories 1	Basement	Pounding Potential No
Plan Irregularities		Vertical Irregularities	
Out of Plane Lateral-Force-Resistance Elements		None	
None		None	
None		None	
Falling Hazards		Poor Conditions	
None		None	
None		None	
None		None

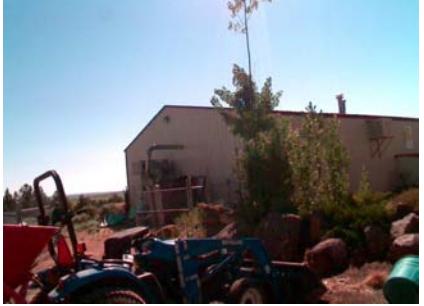
N Primary Structural Type

Enrollment 208	Year Built (Field Verified) 1991	Year Built (Alt. Source) 1991	Est. Decade Built 1990
Total Area (square ft) 54000	Number of Stories 1	Basement	Pounding Potential No
Plan Irregularities None None None		Vertical Irregularities None None None	
Falling Hazards None None None		Poor Conditions None None None
