Lakeview Senior High School

Lake_sch05A

FEMA 154 Rapid Visual Screening Score Card

Rapid Visual Screening - Senate Bill #2 - Seismic Needs Assessment
Oregon Department of Geology and Mineral Industries

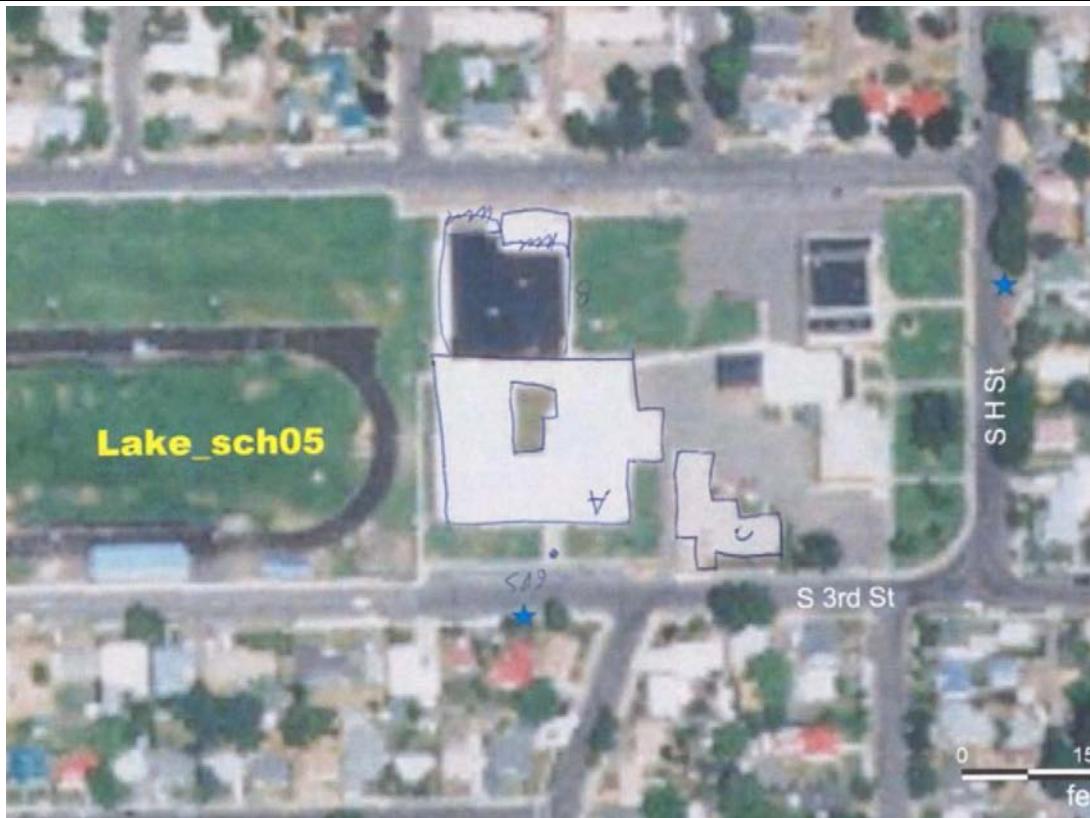
Type	Basic Score	Vert Irreg	Plan Irreg	Pre-Code	Post-Bench	Soil C	Soil D	Soil E	RVS Score
Primary	W2	4.8	-3	0	0	0	0	0	-1.8	0
Secondary		0	0	0	0	0	0	0	0	0
Tertiary		0	0	0	0	0	0	0	0	0

Final Type	Final Score
W2	0

Very High (100%)

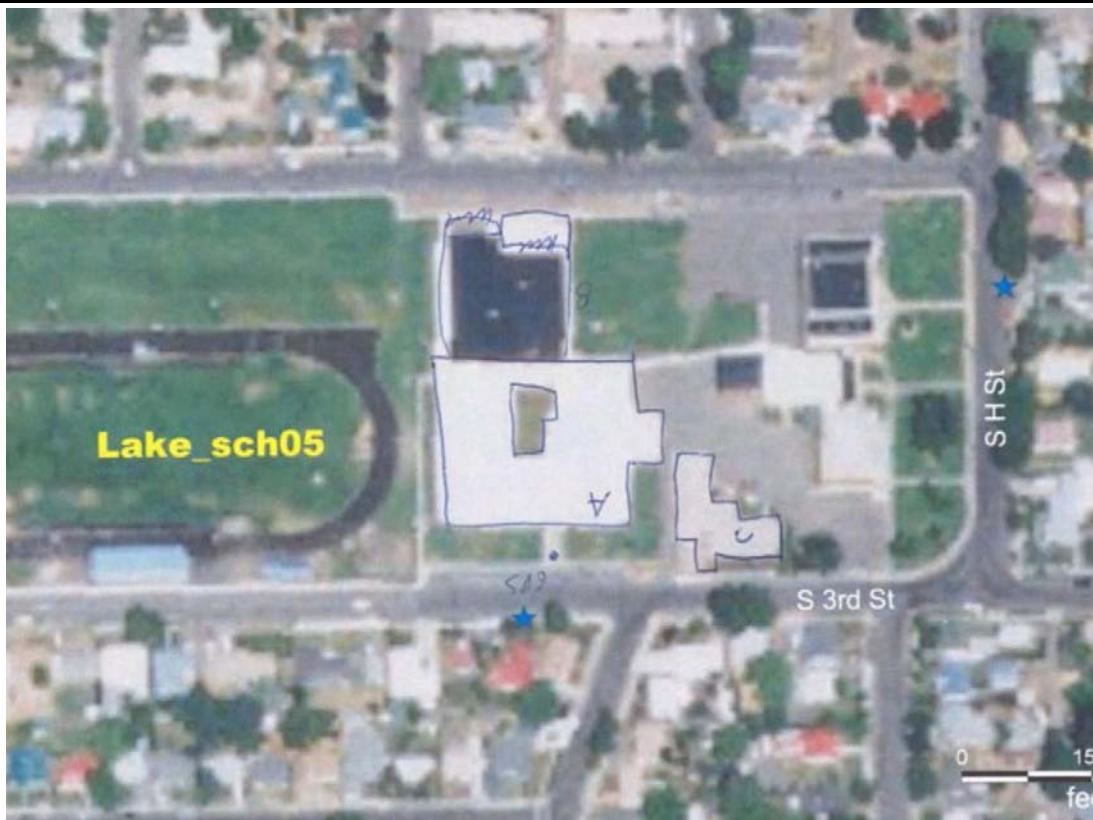
Lake_sch05B

Type	Basic Score	Vert Irreg	Plan Irreg	Pre-Code	Post-Bench	Soil C	Soil D	Soil E	RVS Score
Primary	RM1	3.6	-2	-0.5	0	0	0	0	-1.6	-0.5
Secondary	C2	3.6	-2	-0.5	0	0	0	0	-1.6	-0.5
Tertiary		0	0	0	0	0	0	0	0	0

Final Type	Final Score
RM1	-0.5

Very High (100%)

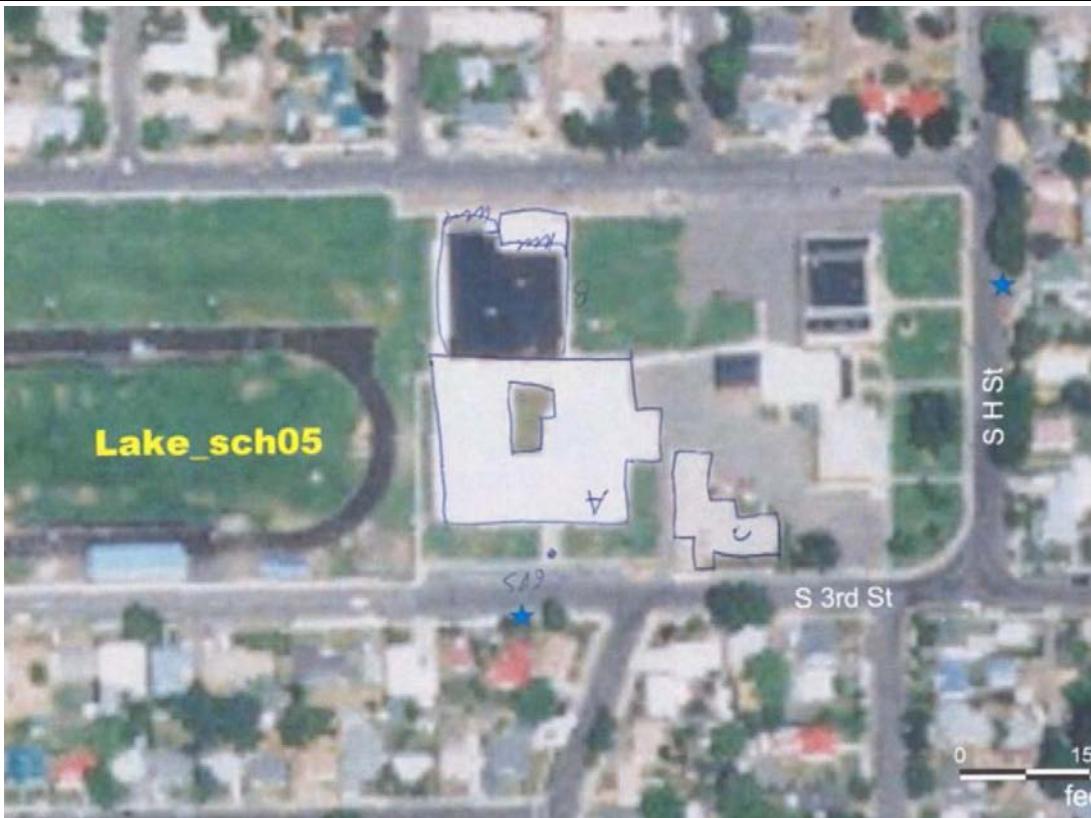
Lake_sch05C

Type	Basic Score	Vert Irreg	Plan Irreg	Pre-Code	Post-Bench	Soil C	Soil D	Soil E	RVS Score
Primary	URM	3.4	-1.5	-0.5	-0.4	0	0	-0.8	0	0.2
Secondary	W2	4.8	-3	-0.5	-0.2	0	0	-1.2	0	-0.1
Tertiary		0	0	0	0	0	0	0	0	0

Final Type	Final Score
W2	-0.1

Very High (100%)

Enrollment 305	Year Built (Field Verified) 1962	Year Built (Alt. Source) 1962	Est. Decade Built 1930
Total Area (square ft) 68881	Number of Stories 1	Basement	Pounding Potential No
Plan Irregularities Reentrant Corners: L Shaped None None		Vertical Irregularities Steps in Elevation View: Single Change None None	
Falling Hazards Unreinforced Chimneys Other: Brick Veneer None		Poor Conditions Cracks None None

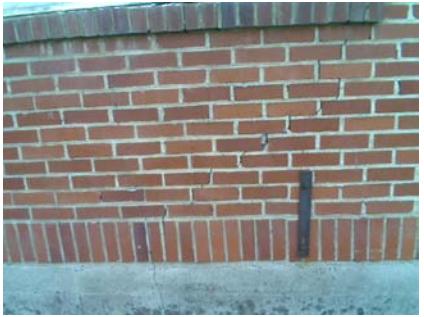
E Elevation View	N Elevation View	W General Site
