Performing Arts

Lane CC

FEMA 154 Rapid Visual Screening Score Card

Rapid Visual Screening - Senate Bill #2 - Seismic Needs Assessment
Oregon Department of Geology and Mineral Industries

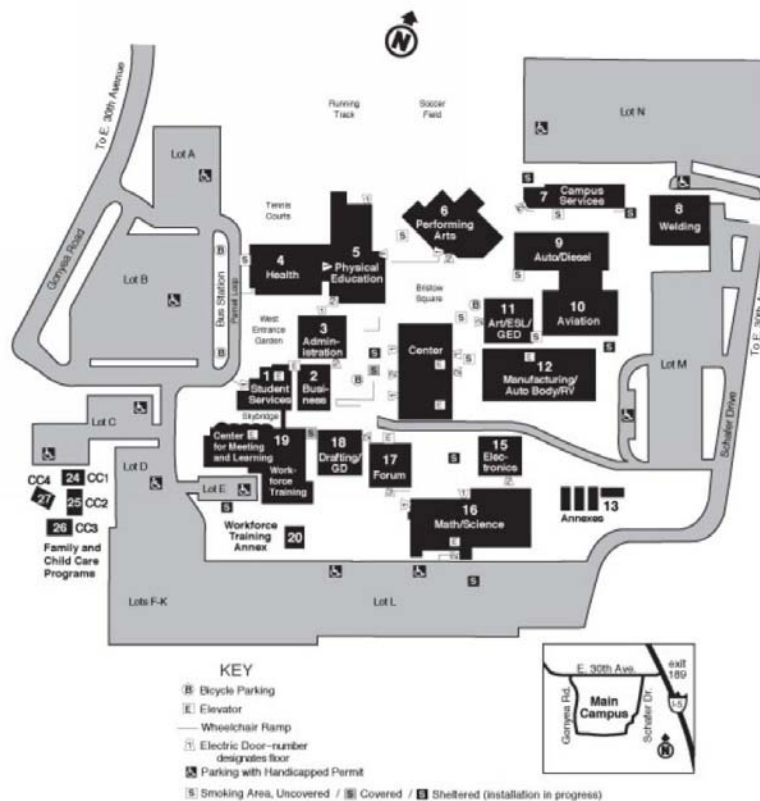
Performing Arts

Type	Basic Score	Vert Irreg	Plan Irreg	Pre-Code	Post-Bench	Soil C	Soil D	Soil E	RVS Score
Primary	C2	2.8	-1	-0.5	0	0	0	0	0	1.3
Secondary	S3	3.2	0	-0.5	0	0	0	0	0	2.7
Tertiary	RM1	2.8	-1	-0.5	0	0	0	0	0	1.3

FEMA-154 Collapse Potential

Moderate (>1%)

Plan Irregularities	Vertical Irregularities
Yes: Unknown	Yes: Unknown
