# Springfield Fire Station 4

Lane\_fir01A

## FEMA 154 Rapid Visual Screening Score Card

Rapid Visual Screening - Senate Bill #2 - Seismic Needs Assessment  
Oregon Department of Geology and Mineral Industries

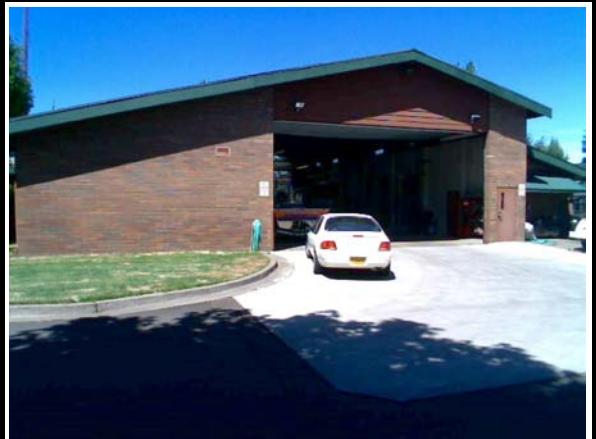
Building Type	County	
Fire - City	Lane	
Street		
1475 5th St		
City	State	Zip
Springfield	OR	97477
Latitude	Longitude	
44.05903	123.01896	
Tracking Code	Inspection Date	
RVS in 2006	8/1/2006

Type	Basic Score	Vert Irreg	Plan Irreg	Pre-Code	Post-Bench	Soil C	Soil D	Soil E	RVS Score
Primary	RM1	2.8	-1	-0.5	0	0	0	0	0	1.3
Secondary		0	0	0	0	0	0	0	0	0
Tertiary		0	0	0	0	0	0	0	0	0

Final Type	Final Score
RM1	1.3

Moderate (>1%)

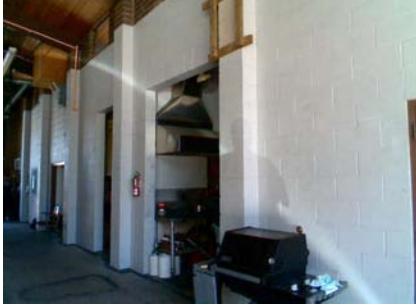
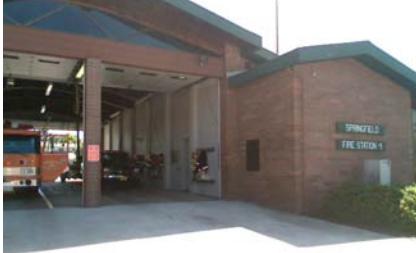
Enrollment	Year Built (Field Verified)	Year Built (Alt. Source)	Est. Decade Built
			1970
Total Area (square ft)	Number of Stories	Basement	Pounding Potential
	1	No	No
Plan Irregularities		Vertical Irregularities	
Reentrant Corners: Other		Steps in Elevation View: 2 to 3 Changes	
Out of Plane Lateral-Force-Resistance Elements		None	
None		None	
Falling Hazards		Poor Conditions	
None		None	
None		None	
None		None

S	Primary Structural Type	W	Plan Irregularity Primary reentrant corner
