Springfield Fire Station 3

Lane_fir07A

FEMA 154 Rapid Visual Screening Score Card

Rapid Visual Screening - Senate Bill #2 - Seismic Needs Assessment
Oregon Department of Geology and Mineral Industries

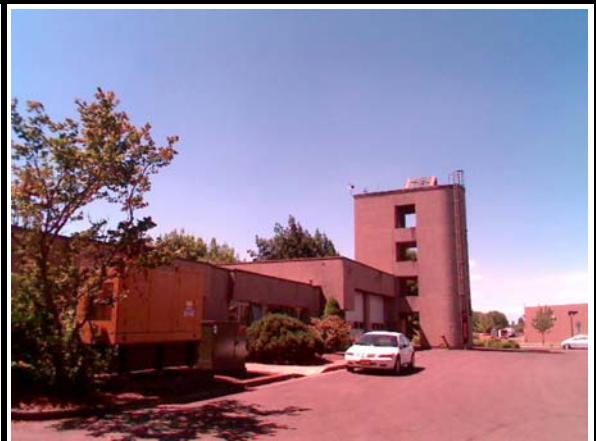
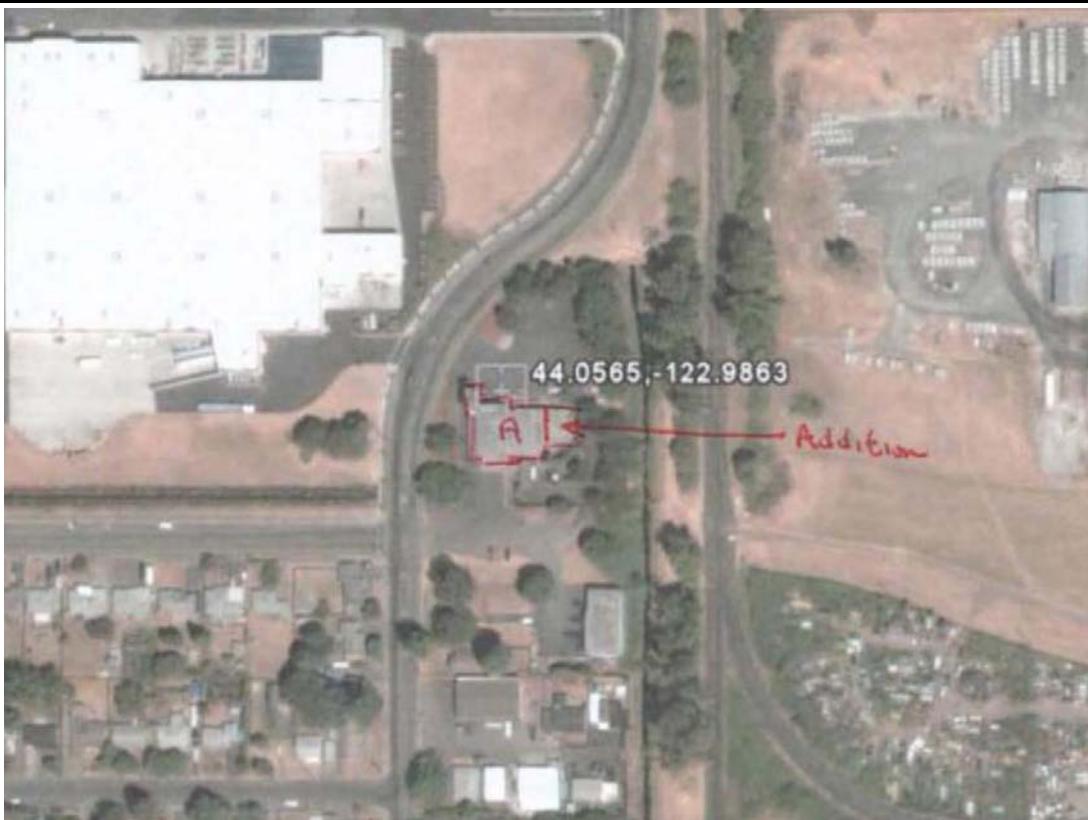
Seismicity Zone: High

Type	Basic Score	Vert Irreg	Plan Irreg	Pre-Code	Post-Bench	Soil C	Soil D	Soil E	RVS Score
Primary	W2	3.8	-2	-0.5	0	0	0	0	0	1.3
Secondary	RM2	2.8	-1	-0.5	0	0	0	0	0	1.3
Tertiary		0	0	0	0	0	0	0	0	0

Final Type	Final Score
W2	1.3

Moderate (>1%)

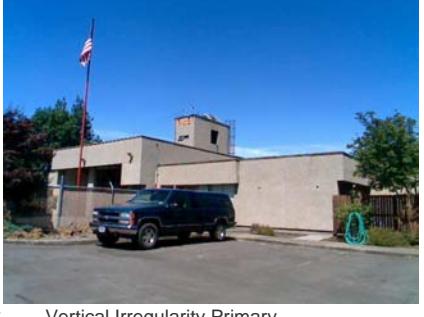
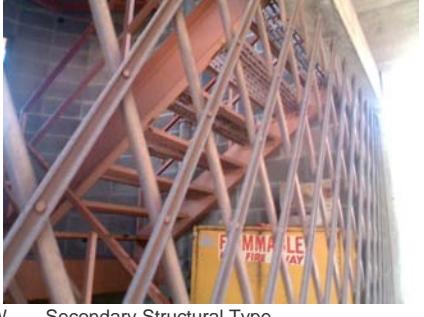
Enrollment	Year Built (Field Verified)	Year Built (Alt. Source)	Est. Decade Built
			1970
Total Area (square ft)	Number of Stories	Basement	Pounding Potential
	1	No	No
Plan Irregularities		Vertical Irregularities	
Reentrant Corners: Other		Steps in Elevation View: 2 to 3 Changes	
Out of Plane Lateral-Force-Resistance Elements		None	
None		None	
Falling Hazards		Poor Conditions	
None		None	
None		None	
None		None

S	Vertical Irregularity Primary	W	Secondary Structural Type
