Springfield Fire Station 1

Lane_fir08A

FEMA 154 Rapid Visual Screening Score Card

Rapid Visual Screening - Senate Bill #2 - Seismic Needs Assessment
Oregon Department of Geology and Mineral Industries

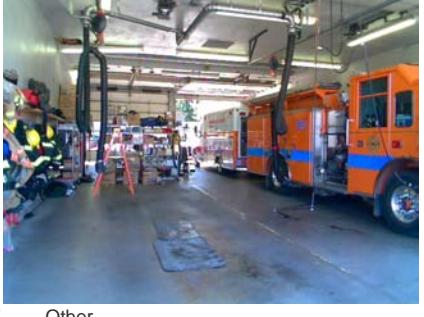
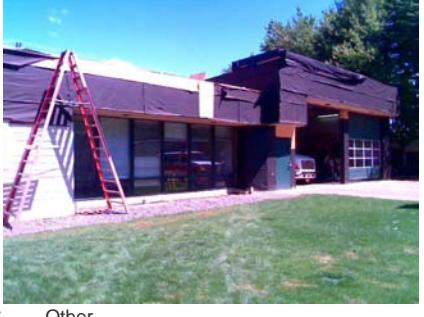
Enrollment	Year Built (Field Verified)	Year Built (Alt. Source)	Est. Decade Built
			1970
Total Area (square ft)	Number of Stories	Basement	Pounding Potential
	1	No	No
Plan Irregularities		Vertical Irregularities	
Reentrant Corners: Other		Steps in Elevation View: Single Change	
Out of Plane Lateral-Force-Resistance Elements		None	
None		None	
Falling Hazards		Poor Conditions	
None		None	
None		None	
None		None

E Other no torsion trucks can drive through.		S Other under construction to remove mold.
