Lane County Fire District 1

Lane_fir12A

FEMA 154 Rapid Visual Screening Score Card

Rapid Visual Screening - Senate Bill #2 - Seismic Needs Assessment
Oregon Department of Geology and Mineral Industries

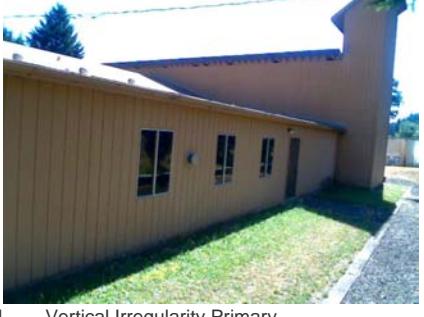
N Vertical Irregularity Primary also shows plan irregularity.		NE Primary Structural Type the east side of this building is sheathed with metal all other sides are wood.
