# Lorane RFPD

## FEMA 154 Rapid Visual Screening Score Card

Rapid Visual Screening - Senate Bill #2 - Seismic Needs Assessment  
Oregon Department of Geology and Mineral Industries

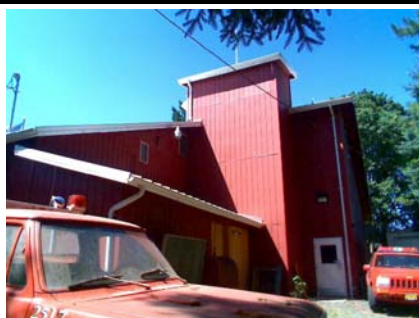
| Reentrant Corners: Other | Steps in Elevation View: 2 to 3 Changes |
| Torsion: Eccentric Stiffness | None |

E Vertical Irregularity Primary  
also shows plan irregularity

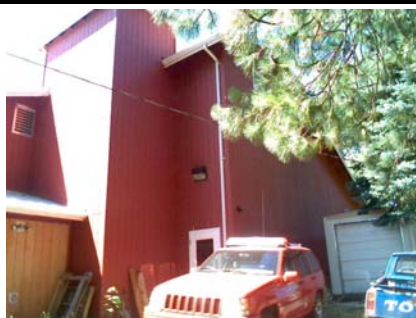
E General Site  
shows solid wall on opposite side of truck door openings
