Mohawk Valley RFD

Lane_fir66A

FEMA 154 Rapid Visual Screening Score Card

Rapid Visual Screening - Senate Bill #2 - Seismic Needs Assessment
Oregon Department of Geology and Mineral Industries

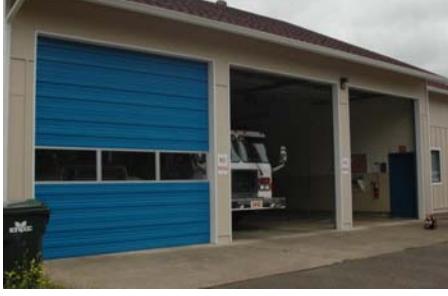
Enrollment	Year Built (Field Verified)	Year Built (Alt. Source)	Est. Decade Built
			1980
Total Area (square ft)	Number of Stories	Basement	Pounding Potential
	1	No	No
Plan Irregularities		Vertical Irregularities	
Reentrant Corners: T shaped		None	
Torsion: Eccentric Stiffness		None	
None		None	
Falling Hazards		Poor Conditions	
None		None	
None		None	
None		None

W Plan Irregularity Secondary
