Awbrey Park Elementary School

Lane_sch03A

FEMA 154 Rapid Visual Screening Score Card

Rapid Visual Screening - Senate Bill #2 - Seismic Needs Assessment
Oregon Department of Geology and Mineral Industries

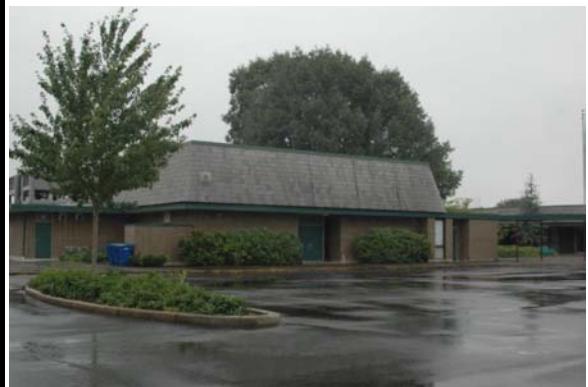
Type	Basic Score	Vert Irreg	Plan Irreg	Pre-Code	Post-Bench	Soil C	Soil D	Soil E	RVS Score
Primary	RM1	2.8	-1	-0.5	0	0	0	0	0	1.3
Secondary		0	0	0	0	0	0	0	0	0
Tertiary		0	0	0	0	0	0	0	0	0

Final Type	Final Score
RM1	1.3

Moderate (>1%)

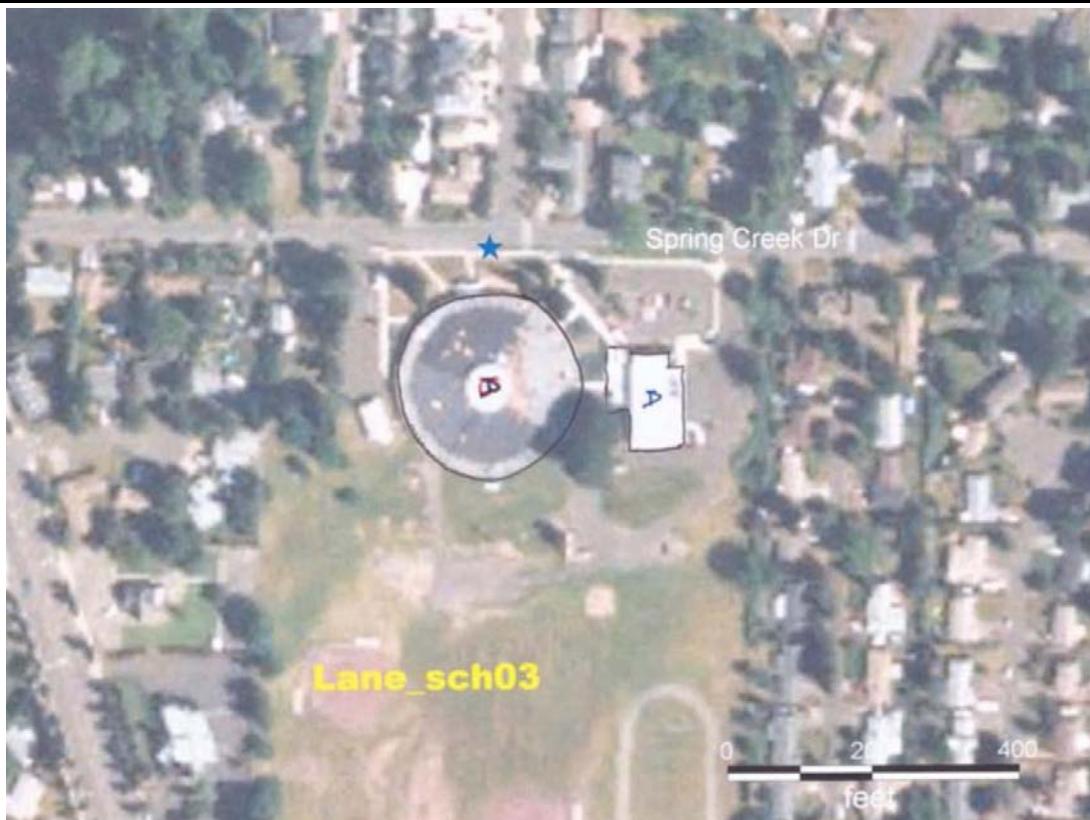
Enrollment 472	Year Built (Field Verified) 1967	Year Built (Alt. Source) 1967	Est. Decade Built 1960
Total Area (square ft) 56816	Number of Stories 1	Basement	Pounding Potential No
Plan Irregularities Reentrant Corners: Other None None		Vertical Irregularities Steps in Elevation View: 2 to 3 Changes None None	
Falling Hazards None None None		Poor Conditions None None None

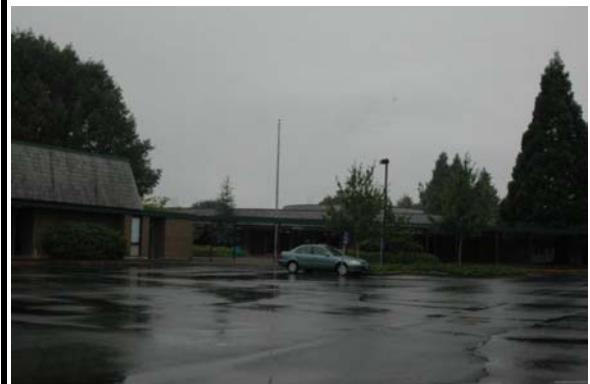
Lane_sch03B

Type	Basic Score	Vert Irreg	Plan Irreg	Pre-Code	Post-Bench	Soil C	Soil D	Soil E	RVS Score
Primary	RM1	2.8	0	-0.5	0	0	0	0	0	2.3
Secondary		0	0	0	0	0	0	0	0	0
Tertiary		0	0	0	0	0	0	0	0	0

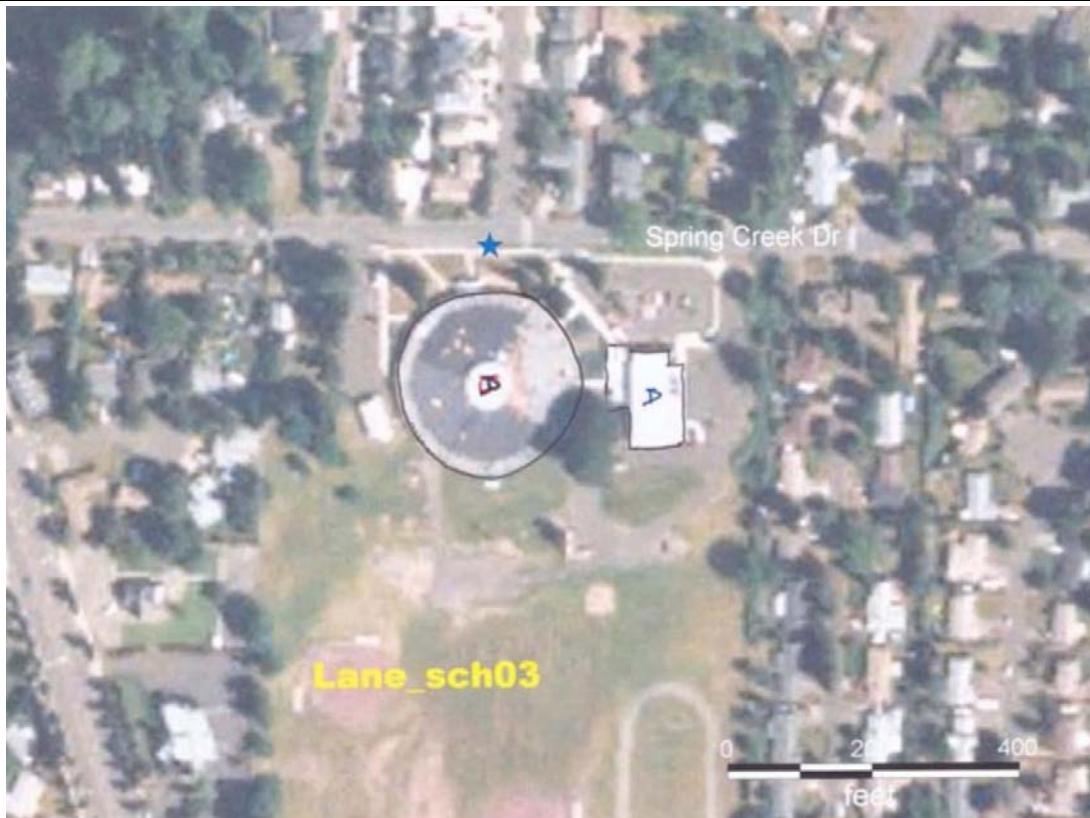
Final Type	Final Score
RM1	2.3

Low (<1%)

Enrollment 472	Year Built (Field Verified) 1967	Year Built (Alt. Source) 1967	Est. Decade Built 1960
Total Area (square ft) 56816	Number of Stories 1	Basement	Pounding Potential No
Plan Irregularities Non-Parallel System None None		Vertical Irregularities None None None	
Falling Hazards None None None		Poor Conditions None None None
