Guy Lee Elementary School

Building Type		County	
School		Lane	
Street			
755 Harlow Rd			
City		State	Zip
Springfield		OR	97477
Latitude		Longitude	
44.06982		123.03875	
Tracking Code		Inspection Date	
Previous FEMA-154 Report		9/15/2006

Rapid Visual Screening - Senate Bill #2 - Seismic Needs Assessment
Oregon Department of Geology and Mineral Industries

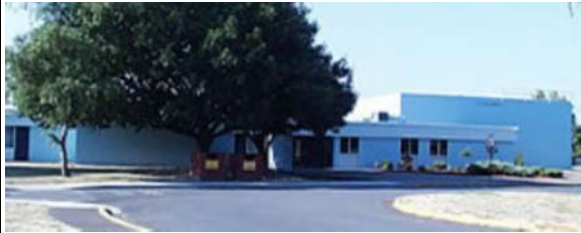
Seismicity Zone: High											Guy Lee Elementary School	
FEMA 154 Rapid Visual Screening Score Card											Final RVS Score	
	Type	Basic Score	Vert Irreg	Plan Irreg	Pre-Code	Post-Bench	Soil C	Soil D	Soil E	RVS Score	Final Type	Final Score
Primary	RM1	2.8	0	0	0	0	0	0	0	2.8	RM1	2.8
Secondary		0	0	0	0	0	0	0	0	0		
Tertiary		0	0	0	0	0	0	0	0	0		
											FEMA-154 Collapse Potential	
											Low (<1%)
