# Thurston Elementary School

Springfield SD 19

Rapid Visual Screening - Senate Bill #2 - Seismic Needs Assessment  
Oregon Department of Geology and Mineral Industries

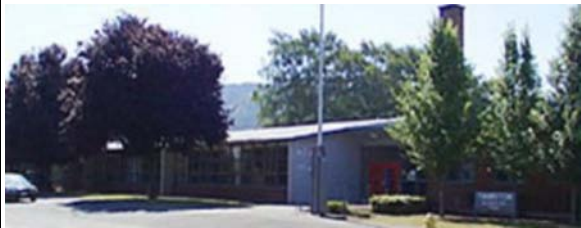
Seismicity Zone: Moderate											Thurston Elementary School	
FEMA 154 Rapid Visual Screening Score Card											Final RVS Score	
	Type	Basic Score	Vert Irreg	Plan Irreg	Pre-Code	Post-Bench	Soil C	Soil D	Soil E	RVS Score	Final Type	Final Score
Primary	W2	4.8	0	0	0	0	0	0	0	4.8	W2	4.8
Secondary		0	0	0	0	0	0	0	0	0		
Tertiary		0	0	0	0	0	0	0	0	0		
											FEMA-154 Collapse Potential	
											Low (<1%)
