# Yolanda Elementary School

Springfield SD 19

Rapid Visual Screening - Senate Bill #2 - Seismic Needs Assessment  
Oregon Department of Geology and Mineral Industries

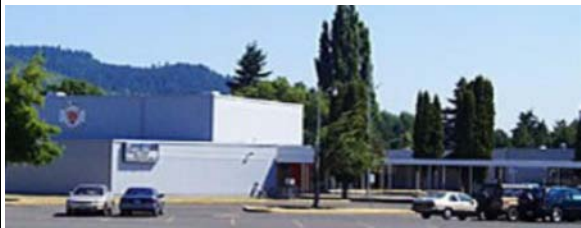
Seismicity Zone: High											Yolanda Elementary School	
FEMA 154 Rapid Visual Screening Score Card											Final RVS Score	
	Type	Basic Score	Vert Irreg	Plan Irreg	Pre-Code	Post-Bench	Soil C	Soil D	Soil E	RVS Score	Final Type	Final Score
Primary	W2	3.8	0	0	0	0	0	0	0	3.8	W2	3.8
Secondary		0	0	0	0	0	0	0	0	0		
Tertiary		0	0	0	0	0	0	0	0	0		
											FEMA-154 Collapse Potential	
											Low (<1%)
