# Trent Elementary School

Lane\_sch88A

## FEMA 154 Rapid Visual Screening Score Card

Rapid Visual Screening - Senate Bill #2 - Seismic Needs Assessment  
Oregon Department of Geology and Mineral Industries

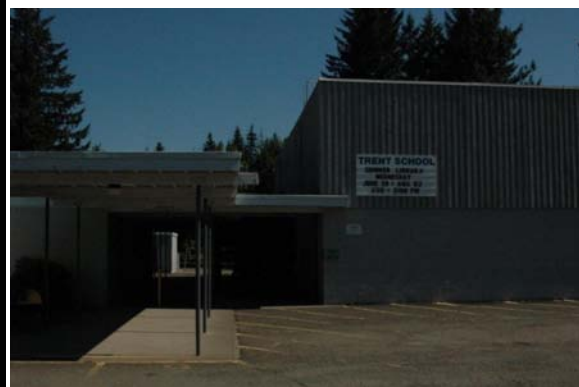
Type	Basic Score	Vert Irreg	Plan Irreg	Pre-Code	Post-Bench	Soil C	Soil D	Soil E	RVS Score
Primary	W2	4.8	0	0	0	0	-0.8	0	0	4
Secondary	RM1	3.6	0	0	0	0	-0.8	0	0	2.8
Tertiary		0	0	0	0	0	0	0	0	0

RM1

2.8

FEMA-154 Collapse Potential

Low (<1%)

Plan Irregularities	Vertical Irregularities
None	None
None	None
None	None

Falling Hazards	Poor Conditions
None	None
None	None
None	None

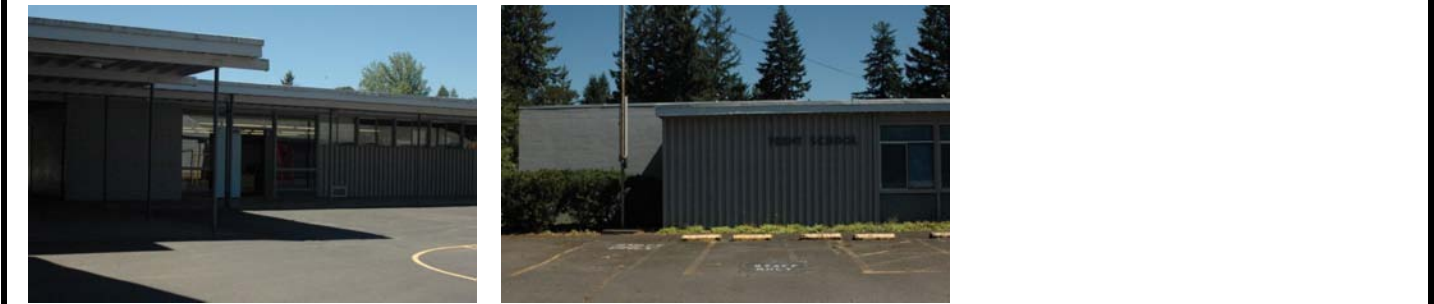
N    Primary Structural Type

S    General Site

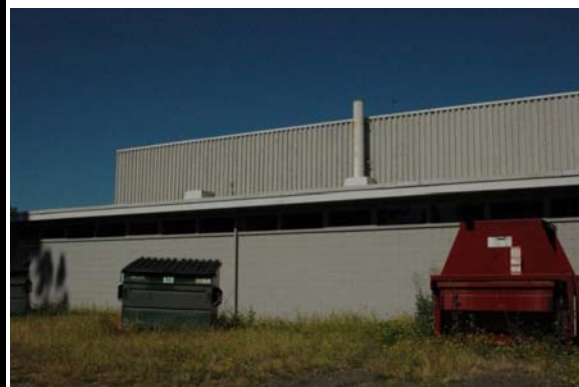
Lane\_sch88B

Type	Basic Score	Vert Irreg	Plan Irreg	Pre-Code	Post-Bench	Soil C	Soil D	Soil E	RVS Score
Primary	RM1	3.6	-2	0	0	0	-0.8	0	0	0.8
Secondary		0	0	0	0	0	0	0	0	0
Tertiary		0	0	0	0	0	0	0	0	0

RM1

0.8

FEMA-154 Collapse Potential

High (>10%)

Plan Irregularities	Vertical Irregularities
None	Steps in Elevation View: Single Change
None	None
None	None

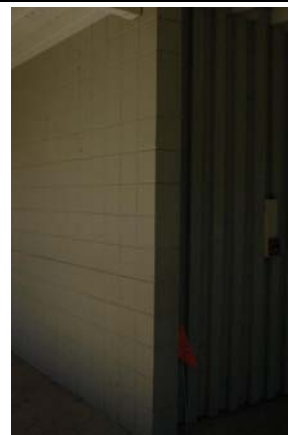
Lane\_sch88C

Type	Basic Score	Vert Irreg	Plan Irreg	Pre-Code	Post-Bench	Soil C	Soil D	Soil E	RVS Score
Primary	W2	4.8	0	-0.5	0	0	-0.8	0	0	3.5
Secondary	RM1	3.6	0	-0.5	0	0	-0.8	0	0	2.3
Tertiary		0	0	0	0	0	0	0	0	0

RM1

2.3

Plan Irregularities	Vertical Irregularities
Reentrant Corners: L Shaped	None
None	None
None	None

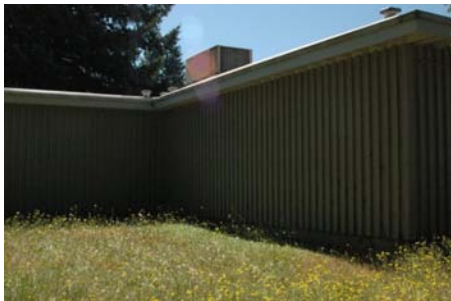
NW Plan Irregularity Primary

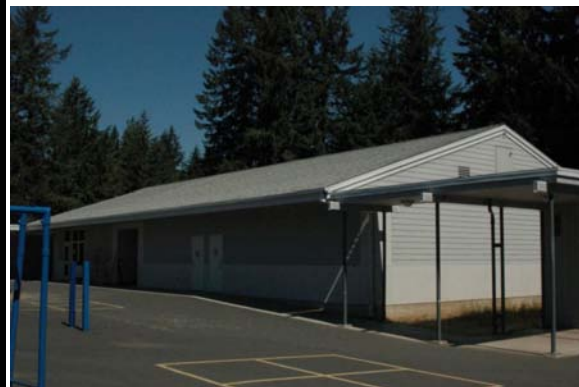
Lane\_sch88D

Type	Basic Score	Vert Irreg	Plan Irreg	Pre-Code	Post-Bench	Soil C	Soil D	Soil E	RVS Score
Primary	W1	5.2	0	0	0	1.6	-0.2	0	0	6.6
Secondary		0	0	0	0	0	0	0	0	0
Tertiary		0	0	0	0	0	0	0	0	0

W1

6.6

Low (<1%)

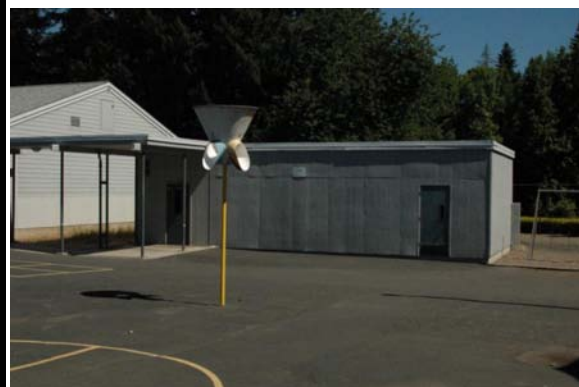
Lane\_sch88E

Type	Basic Score	Vert Irreg	Plan Irreg	Pre-Code	Post-Bench	Soil C	Soil D	Soil E	RVS Score
Primary	W1	5.2	0	0	0	0	-0.2	0	0	5
Secondary		0	0	0	0	0	0	0	0	0
Tertiary		0	0	0	0	0	0	0	0	0

W1

5

Low (<1%)
