Siletz RFPD

Linc_fir24A

Building Type Fire - RFPD	County Lincoln	
Street 7751 Logsden Rd		
City Logsden	State OR	Zip 97357
Latitude 44.74285	Longitude 123.78941	
Tracking Code RVS in 2006	Inspection Date 8/10/2006

FEMA 154 Rapid Visual Screening Score Card

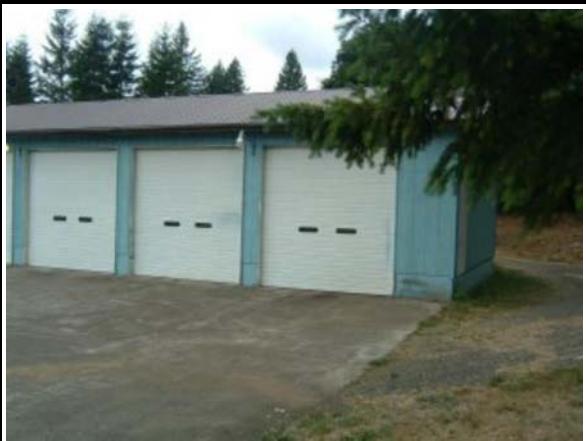
Type	Basic Score	Vert Irreg	Plan Irreg	Pre-Code	Post-Bench	Soil C	Soil D	Soil E	RVS Score
Primary	W1	4.4	0	-0.5	0	0	0	0	0	3.9
Secondary		0	0	0	0	0	0	0	0	0
Tertiary		0	0	0	0	0	0	0	0	0

Final Type	Final Score
W1	3.9

Low (<1%)

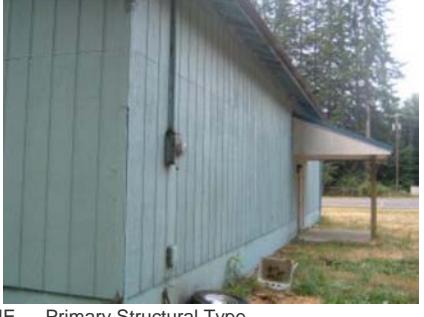
NE Primary Structural Type

Enrollment	Year Built (Field Verified)	Year Built (Alt. Source)	Est. Decade Built
			1970
Total Area (square ft)	Number of Stories	Basement	Pounding Potential
	1	No	No
Plan Irregularities		Vertical Irregularities	
Torsion: Eccentric Stiffness		None	
None		None	
None		None	
Falling Hazards		Poor Conditions	
None		None	
None		None	
None		None
