Sweet Home Fire And Ambulance #21

Linn_fir07A

FEMA 154 Rapid Visual Screening Score Card

Rapid Visual Screening - Senate Bill #2 - Seismic Needs Assessment
Oregon Department of Geology and Mineral Industries

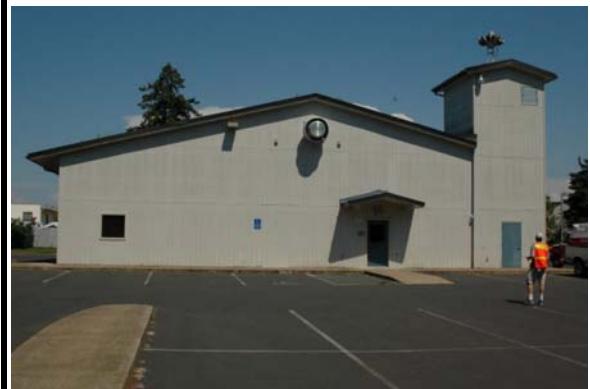
Type	Basic Score	Vert Irreg	Plan Irreg	Pre-Code	Post-Bench	Soil C	Soil D	Soil E	RVS Score
Primary	W2	4.8	-3	0	0	1.6	0	-1.2	0	2.2
Secondary	S3	3.8	0	0	0	0	0	-1	0	2.8
Tertiary		0	0	0	0	0	0	0	0	0

Final Type	Final Score
W2	2.2

Low (<1%)

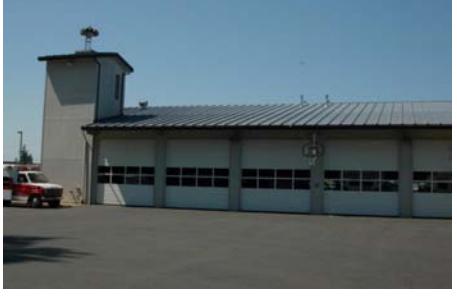
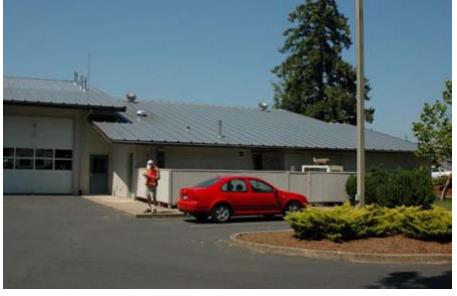
Enrollment	Year Built (Field Verified)	Year Built (Alt. Source)	Est. Decade Built		
		1994	1990		
Total Area (square ft)	Number of Stories	Basement	Pounding Potential		
	1	No	No		
Plan Irregularities		Vertical Irregularities			
Reentrant Corners:Other (Adjacent Build/Entity)		Steps in Elevation View: Single Change			
None		Steps in Elevation View: Single Change (Adjacent Building/Entity)			
None		None			
Falling Hazards		Poor Conditions			
None		None			
None		None			
None		None

S	Vertical Irregularity Primary	N	Plan Irregularity Primary vertical irregularity - adjacent bldg - single step in elevation	NE	General Site

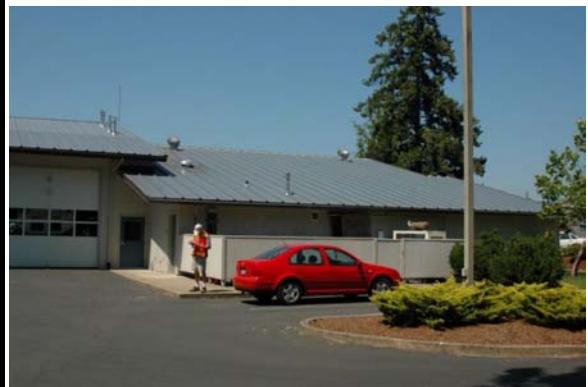
Type	Basic Score	Vert Irreg	Plan Irreg	Pre-Code	Post-Bench	Soil C	Soil D	Soil E	RVS Score
Primary	W1	5.2	0	0	0	1.6	0	-0.6	0	6.2
Secondary		0	0	0	0	0	0	0	0	0
Tertiary		0	0	0	0	0	0	0	0	0

Final Type	Final Score
W1	6.2

Low (<1%)
