# Mill City Middle School

Santiam Canyon SD 129J

## FEMA 154 Rapid Visual Screening Score Card

Rapid Visual Screening - Senate Bill #2 - Seismic Needs Assessment  
Oregon Department of Geology and Mineral Industries

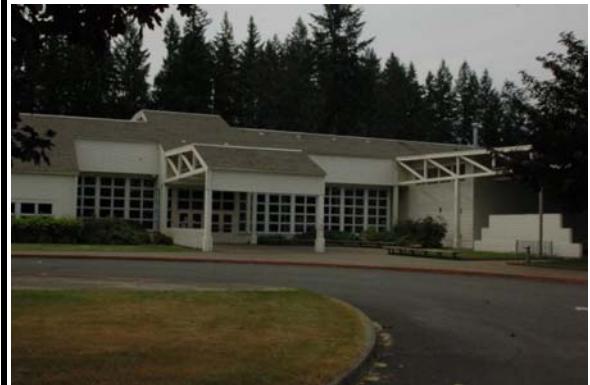
Building Type School	County Linn	
Street 450 SW Evergreen St		
City Mill City	State OR	Zip 97360
Latitude 44.75076	Longitude 122.48119	
Tracking Code RVS in 2006	Inspection Date 6/28/2006

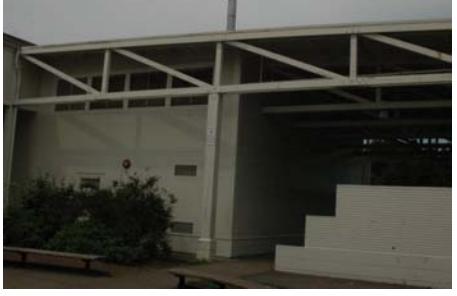
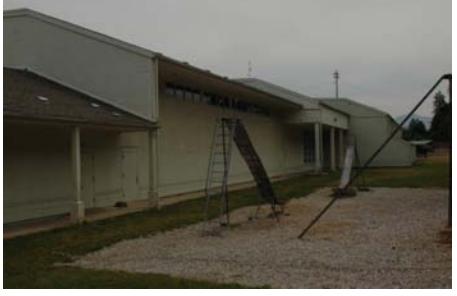
Enrollment 212	Year Built (Field Verified) 1987	Year Built (Alt. Source) 1987	Est. Decade Built 1980
Total Area (square ft) 46547	Number of Stories 2	Basement	Pounding Potential No
<b>Plan Irregularities</b> Reentrant Corners: Other None None		<b>Vertical Irregularities</b> Steps in Elevation View: Very Irregular Changes Internal Discontinuous Diaphragm (large internal opening) None	
<b>Falling Hazards</b> None None None		<b>Poor Conditions</b> None None None

E Primary Structural Type		S Vertical Irregularity Primary	
		N Plan Irregularity Primary
