Vale Middle School

Malh_sch12A

FEMA 154 Rapid Visual Screening Score Card

Rapid Visual Screening - Senate Bill #2 - Seismic Needs Assessment
Oregon Department of Geology and Mineral Industries

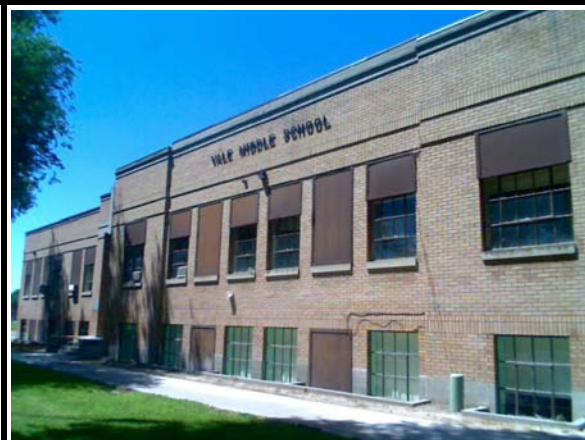
Seismicity Zone: Moderate

Type	Basic Score	Vert Irreg	Plan Irreg	Pre-Code	Post-Bench	Soil C	Soil D	Soil E	RVS Score
Primary	C2	3.6	-2	-0.5	0	0	0	-1.2	0	-0.1
Secondary		0	0	0	0	0	0	0	0	0
Tertiary		0	0	0	0	0	0	0	0	0

Very High (100%)

Enrollment	Year Built (Field Verified)	Year Built (Alt. Source)	Est. Decade Built
121		1950	1950
Total Area (square ft)	Number of Stories	Basement	Pounding Potential
13035	1	Yes	Yes

Plan Irregularities	Vertical Irregularities
Out of Plane Lateral-Force-Resistance Elements	Steps in Elevation View: Single Change (Adjacent Building/Entity)
Reentrant Corners: L Shaped (Adjacent Build/Entity)	None
None	None

Falling Hazards	Poor Conditions
Parapets: General	None
Other: Brick Veneer	None
None	None

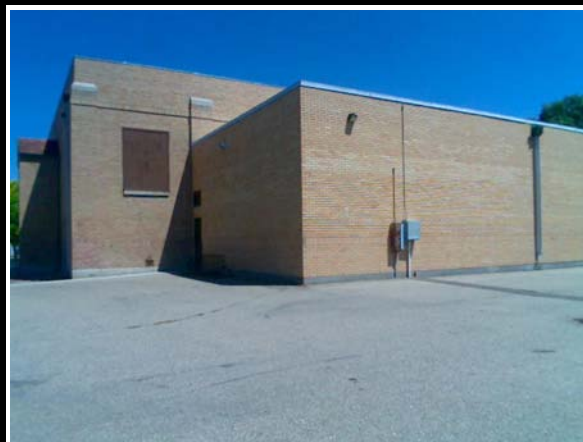
Seismicity Zone: Moderate

Type	Basic Score	Vert Irreg	Plan Irreg	Pre-Code	Post-Bench	Soil C	Soil D	Soil E	RVS Score
Primary	C2	3.6	-2	-0.5	0	0	0	-1.2	0	-0.1
Secondary	RM1	3.6	-2	-0.5	0	0	0	-1.2	0	-0.1
Tertiary		0	0	0	0	0	0	0	0	0

Very High (100%)

Enrollment	Year Built (Field Verified)	Year Built (Alt. Source)	Est. Decade Built
121		1950	1980
Total Area (square ft)	Number of Stories	Basement	Pounding Potential
13035	1	No	Yes

Plan Irregularities	Vertical Irregularities
Reentrant Corners:L shaped (Adjacent Build/Entity)	Steps in Elevation View: Single Change (Adjacent Building/Entity)
None	None
None	None

Falling Hazards	Poor Conditions
Other: Brick Veneer	None
None	None
None	None
