Phase III/Counseling (#002)

Chemeketa CC

FEMA 154 Rapid Visual Screening Score Card

Rapid Visual Screening - Senate Bill #2 - Seismic Needs Assessment
Oregon Department of Geology and Mineral Industries

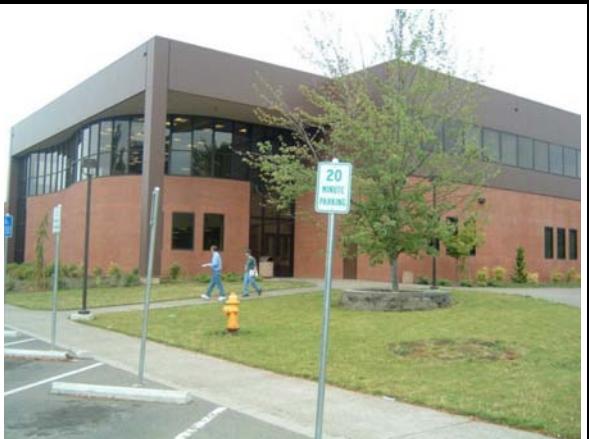
Seismicity Zone: High

S2 0.4

High (>10%)

Enrollment	Year Built (Field Verified)	Year Built (Alt. Source)	Est. Decade Built
83218	1976	1976	1970
Total Area (square ft)	Number of Stories	Basement	Pounding Potential
83218	2	No	No
Plan Irregularities		Vertical Irregularities	
Yes: Unknown		Yes: Unknown	
Falling Hazards		Poor Conditions	
None			
None			
None

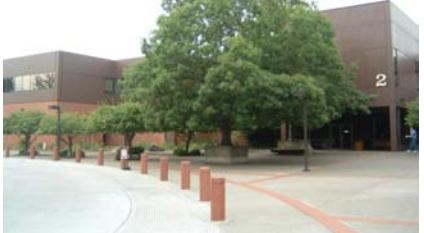
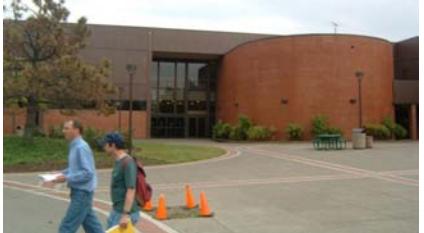
S	General Site	S	General Site
