Admin/Classrooms (#022)

Chemeketa CC

FEMA 154 Rapid Visual Screening Score Card

Rapid Visual Screening - Senate Bill #2 - Seismic Needs Assessment
Oregon Department of Geology and Mineral Industries

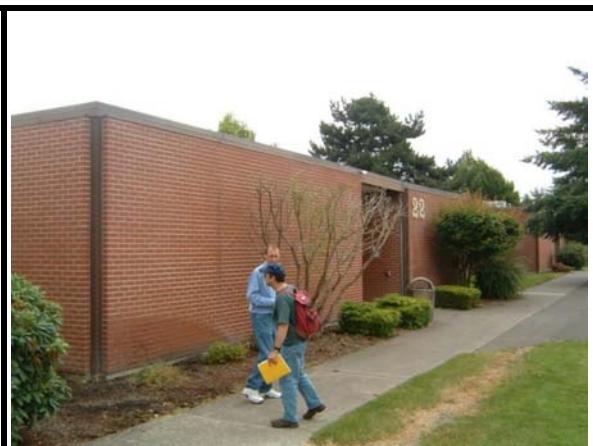
Seismicity Zone: High

Type	Basic Score	Vert Irreg	Plan Irreg	Pre-Code	Post-Bench	Soil C	Soil D	Soil E	RVS Score
Primary	RM1	2.8	-1	-0.5	0	0	0	-0.6	0	0.7
Secondary		0	0	0	0	0	0	0	0	0
Tertiary		0	0	0	0	0	0	0	0	0

Final Type	Final Score
RM1	0.7

High (>10%)
