## Wilmeth Trade (#004)

Chemeketa CC

FEMA 154 Rapid Visual Screening Score Card

Rapid Visual Screening - Senate Bill #2 - Seismic Needs Assessment  
Oregon Department of Geology and Mineral Industries

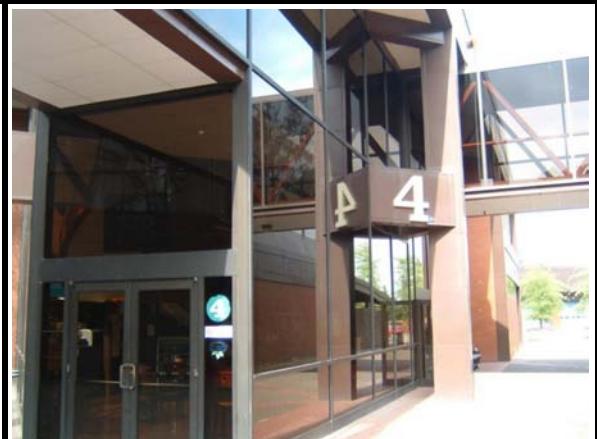
Seismicity Zone: High

Final Type	Final Score
RM1	0.7

High (>10%)

Enrollment	Year Built (Field Verified)	Year Built (Alt. Source)	Est. Decade Built
	1975	1975	1970
Total Area (square ft)	Number of Stories	Basement	Pounding Potential
59378	2	No	No
Plan Irregularities		Vertical Irregularities	
Yes: Unknown		Yes: Unknown	
Falling Hazards		Poor Conditions	
None			
None			
None
