Chemeketa CC

FEMA 154 Rapid Visual Screening Score Card

Learning Resource (#009)

Rapid Visual Screening - Senate Bill #2 - Seismic Needs Assessment
 Oregon Department of Geology and Mineral Industries

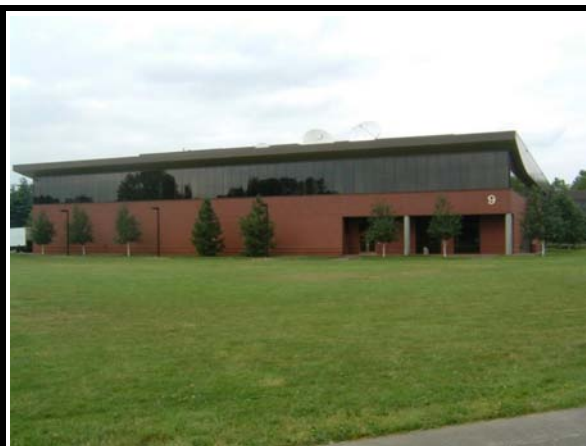
Type	Basic Score	Vert Irreg	Plan Irreg	Pre-Code	Post-Bench	Soil C	Soil D	Soil E	RVS Score
Primary	RM2	2.8	-1	-0.5	0	2.6	0	-0.6	0	3.3
Secondary	RM1	2.8	-1	-0.5	0	0	0	-0.6	0	0.7
Tertiary		0	0	0	0	0	0	0	0	0

FEMA-154 Collapse Potential

High (>10%)
