# Silverton RFPD Victor Point Station #2

Mari\_fir03A

## FEMA 154 Rapid Visual Screening Score Card

Rapid Visual Screening - Senate Bill #2 - Seismic Needs Assessment  
Oregon Department of Geology and Mineral Industries

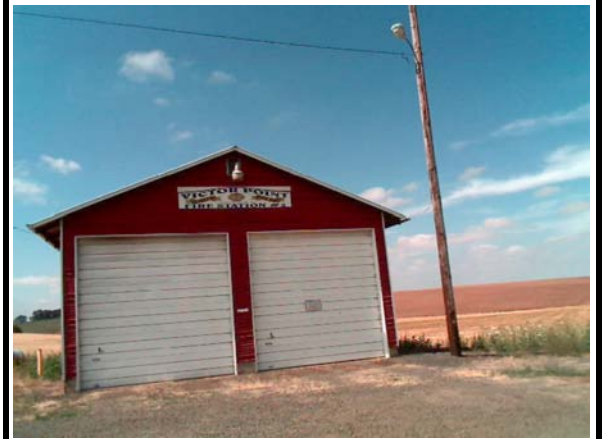
Seismicity Zone: High

| | Type | Basic Score | Vert Irreg | Plan Irreg | Pre-Code | Post-Bench | Soil C | Soil D | Soil E | RVS Score |
| Primary | W1 | 4.4 | 0 | -0.5 | 0 | 0 | 0 | 0 | 0 | 3.9 |

## Final RVS Score

W1

3.9

FEMA-154 Collapse Potential

Low (<1%)
