Richmond Elementary School

Salem-Keizer SD 24J

FEMA 154 Rapid Visual Screening Score Card

Rapid Visual Screening - Senate Bill #2 - Seismic Needs Assessment
Oregon Department of Geology and Mineral Industries

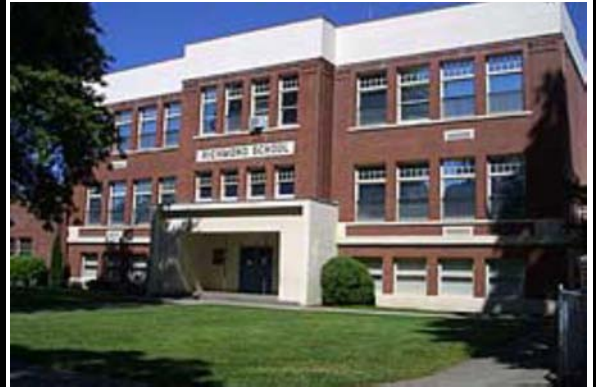
Seismicity Zone: High

Type	Basic Score	Vert Irreg	Plan Irreg	Pre-Code	Post-Bench	Soil C	Soil D	Soil E	RVS Score
Primary	C2	2.8	-1	-0.5	-1	0	-0.4	0	0	-0.1
Secondary		0	0	0	0	0	0	0	0	0
Tertiary		0	0	0	0	0	0	0	0	0

FEMA-154 Collapse Potential

Very High (100%)
