## FEMA 154 Rapid Visual Screening Score Card

# McNary High School

Rapid Visual Screening - Senate Bill #2 - Seismic Needs Assessment  
Oregon Department of Geology and Mineral Industries

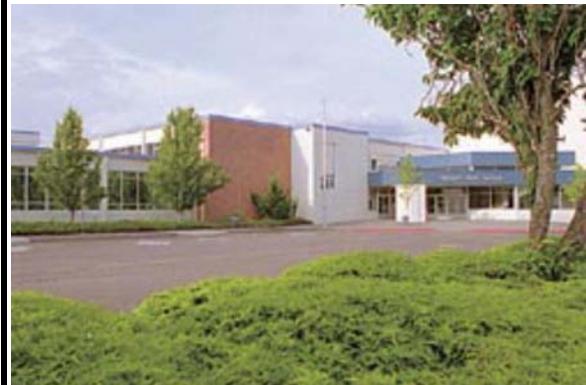
Seismicity Zone: High

Type	Basic Score	Vert Irreg	Plan Irreg	Pre-Code	Post-Bench	Soil C	Soil D	Soil E	RVS Score
Primary	C2	2.8	-1	-0.5	0	0	0	0	-0.8	0.5
Secondary		0	0	0	0	0	0	0	0	0
Tertiary		0	0	0	0	0	0	0	0	0

Final Type	Final Score
C2	0.5

High (&gt;10%)
