Lexington VFD

FEMA 154 Rapid Visual Screening Score Card

Rapid Visual Screening - Senate Bill #2 - Seismic Needs Assessment
Oregon Department of Geology and Mineral Industries

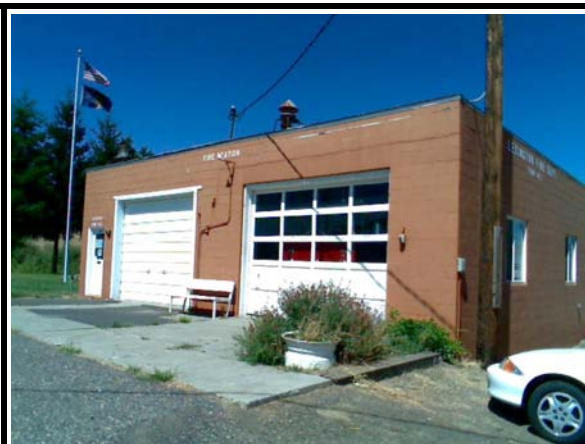
Building Type		County	
Fire - City		Morrow	
Street			
150 W Main St			
City	State	Zip	
Lexington	OR	97839	
Latitude		Longitude	
45.44579		119.68516	
Tracking Code		Inspection Date	
RVS in 2006		7/25/2006

Seismicity Zone: Moderate

Type	Basic Score	Vert Irreg	Plan Irreg	Pre-Code	Post-Bench	Soil C	Soil D	Soil E	RVS Score
Primary	RM1	3.6	0	-0.5	0	0	0	0	0	3.1
Secondary		0	0	0	0	0	0	0	0	0
Tertiary		0	0	0	0	0	0	0	0	0
