# Cascade - Terrell Hall

Building Type		County	
Community_College		Multnomah	
Street			
705 N Killingsworth St			
City	State	Zip	
Portland	OR	97217	
Latitude		Longitude	
45.56394		122.67355	
Tracking Code		Inspection Date	
RVS2006 & FEMA154		6/29/2006

## FEMA 154 Rapid Visual Screening Score Card

Rapid Visual Screening - Senate Bill #2 - Seismic Needs Assessment  
Oregon Department of Geology and Mineral Industries

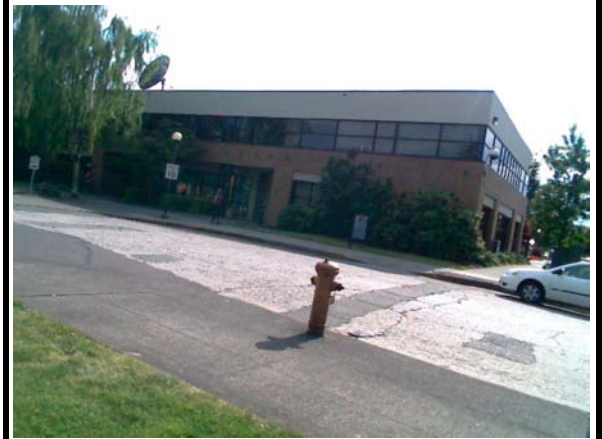
Type	Basic Score	Vert Irreg	Plan Irreg	Pre-Code	Post-Bench	Soil C	Soil D	Soil E	RVS Score
Primary	RM1	2.8	-1	-0.5	0	0	-0.4	0	0	0.9
Secondary		0	0	0	0	0	0	0	0	0
Tertiary		0	0	0	0	0	0	0	0	0

FEMA-154 Collapse Potential

High (>10%)
