# Bridger Elementary School

Portland SD 1J

## FEMA 154 Rapid Visual Screening Score Card

Rapid Visual Screening - Senate Bill #2 - Seismic Needs Assessment  
Oregon Department of Geology and Mineral Industries

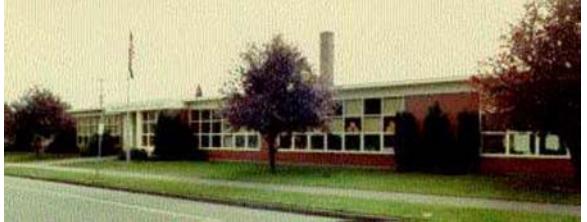
Building Type	County
School	Multnomah
Street	
7910 Se Market St	
City	State Zip
Portland	OR 97215
Latitude	Longitude
45.51054	122.58218
Tracking Code	Inspection Date
Already Retrofitted	9/15/2006
