# Kellogg Middle School

## FEMA 154 Rapid Visual Screening Score Card

Rapid Visual Screening - Senate Bill #2 - Seismic Needs Assessment  
Oregon Department of Geology and Mineral Industries

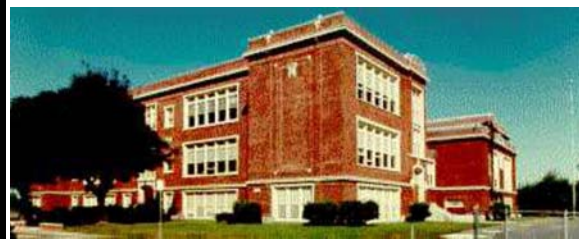
Type	Basic Score	Vert Irreg	Plan Irreg	Pre-Code	Post-Bench	Soil C	Soil D	Soil E	RVS Score
Primary	C2	2.8	-1	-0.5	-1	0	-0.4	0	0	-0.1
Secondary										
Tertiary										0

Moderate (>1%)
