Oakdale Heights Elementary School

FEMA 154 Rapid Visual Screening Score Card

Rapid Visual Screening - Senate Bill #2 - Seismic Needs Assessment
Oregon Department of Geology and Mineral Industries

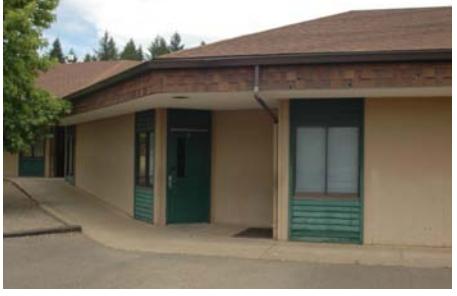
NE Plan Irregularity Primary	SW Vertical Irregularity Primary steps in elevation also, and reentrant corners	SE Other the play area that is between each segment of A-- almost might be considered a gym (three walls).
