Moro RFPD

Building Type Fire - RFPD	County Sherman	
Street 309 Dewey St		
City Moro	State OR	Zip 97039
Latitude 45.48158	Longitude 120.73204	
Tracking Code New Building	Inspection Date 8/28/2006

## FEMA 154 Rapid Visual Screening Score Card

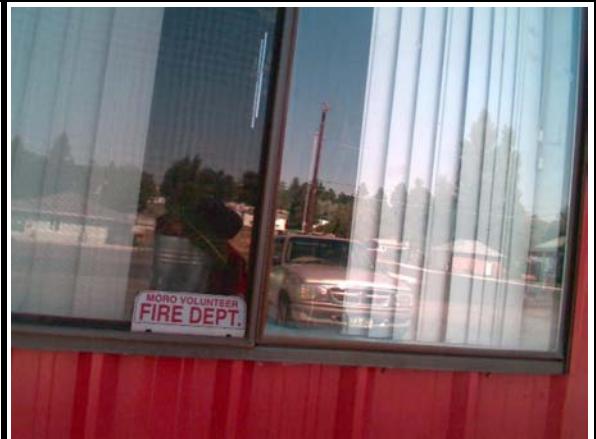
Seismicity Zone: Moderate

Type	Basic Score	Vert Irreg	Plan Irreg	Pre-Code	Post-Bench	Soil C	Soil D	Soil E	RVS Score
Primary	S3	3.8	0	0	0	0	-0.6	0	0	3.2
Secondary		0	0	0	0	0	0	0	0	0
Tertiary		0	0	0	0	0	0	0	0	0

Final Type	Final Score
S3	3.2

Low (<1%)

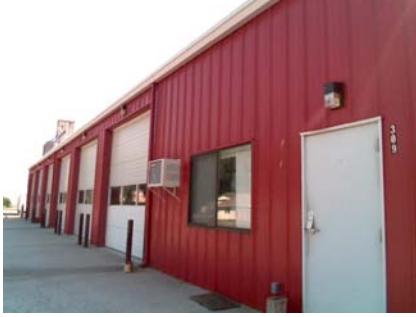
NE General Site	
<p>THIS WAS THE GARAGE NEXT DOOR, BUT I'M PRETTY SURE IT'S NOT PART OF THE SITE. THERE WAS A PIGSTY BEHIND THIS BLDG WITH 3 HUGE PIGS.</p>
