FEMA 154 Rapid Visual Screening Score Card

Morrow Hall

Umat_coc02A

Rapid Visual Screening - Senate Bill #2 - Seismic Needs Assessment
Oregon Department of Geology and Mineral Industries

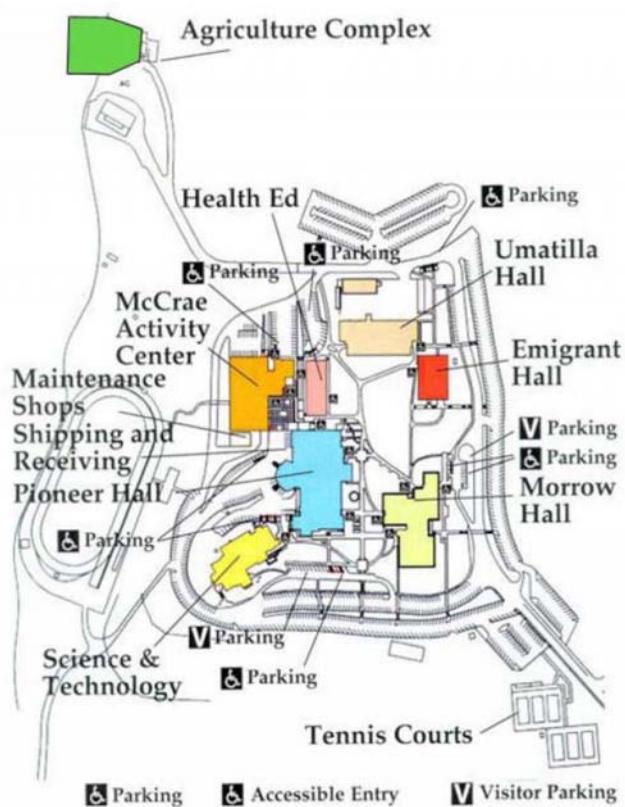
Morrow Hall

Type	Basic Score	Vert Irreg	Plan Irreg	Pre-Code	Post-Bench	Soil C	Soil D	Soil E	RVS Score
Primary	W2	4.8	-3	-0.5	0	0	0	0	0	1.3
Secondary		0	0	0	0	0	0	0	0	0
Tertiary		0	0	0	0	0	0	0	0	0

Final Type	Final Score
W2	1.3

Moderate (>1%)

Enrollment	Year Built (Field Verified)	Year Built (Alt. Source)	Est. Decade Built
	1964	1964	1960
Total Area (square ft)	Number of Stories	Basement	Pounding Potential
39214	1	Yes	No
Plan Irregularities		Vertical Irregularities	
Yes: Unknown		Yes: Unknown	
Falling Hazards		Poor Conditions	
None			
None
