Helix RFPD

Building Type		County	
Fire - RFPD		Umatilla	
Street			
125 Concord			
City	State	Zip	
Helix	OR	97835	
Latitude		Longitude	
45.85036		118.65533	
Tracking Code		Inspection Date	
RVS in 2006		8/4/2006

FEMA 154 Rapid Visual Screening Score Card

Rapid Visual Screening - Senate Bill #2 - Seismic Needs Assessment
Oregon Department of Geology and Mineral Industries

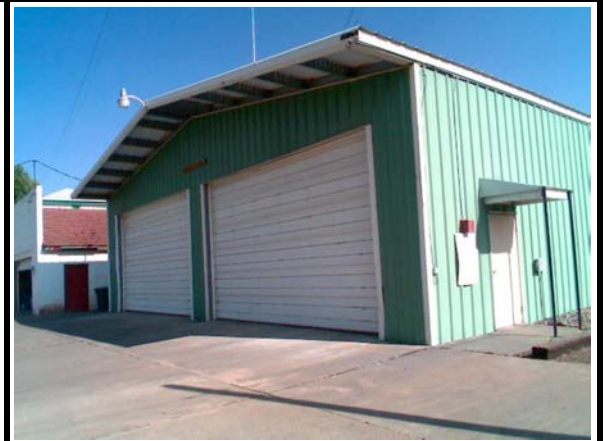
Seismicity Zone: Moderate

Type	Basic Score	Vert Irreg	Plan Irreg	Pre-Code	Post-Bench	Soil C	Soil D	Soil E	RVS Score
Primary	S3	3.8	0	0	0	0	-0.6	0	0	3.2
Secondary		0	0	0	0	0	0	0	0	0
Tertiary		0	0	0	0	0	0	0	0	0
