# East Umatilla County RFPD

Umat\_fir08A

Building Type Fire - RFPD	County Umatilla	
Street 57770 Hwy 204		
City Weston	State OR	Zip 97886
Latitude 45.7879	Longitude 118.2525	
Tracking Code New Building	Inspection Date 8/4/2006

Rapid Visual Screening - Senate Bill #2 - Seismic Needs Assessment  
Oregon Department of Geology and Mineral Industries

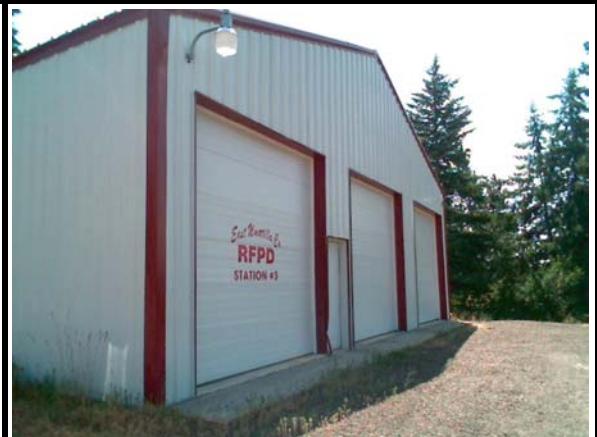
Seismicity Zone: Moderate										
FEMA 154 Rapid Visual Screening Score Card										
	Type	Basic Score	Vert Irreg	Plan Irreg	Pre-Code	Post-Bench	Soil C	Soil D	Soil E	RVS Score
Primary	S3	3.8	0	-0.5	0	0	0	0	0	3.3
Secondary		0	0	0	0	0	0	0	0	0
Tertiary		0	0	0	0	0	0	0	0	0

Final Type	Final Score
S3	3.3

Low (<1%)
