# Milton - Freewater Fire Department

## FEMA 154 Rapid Visual Screening Score Card

Rapid Visual Screening - Senate Bill #2 - Seismic Needs Assessment  
Oregon Department of Geology and Mineral Industries

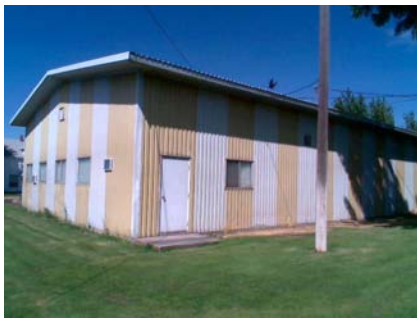
SW Elevation View

Plan Irregularities	Vertical Irregularities
Torsion: Eccentric Stiffness	None
None	None
None	None

Falling Hazards	Poor Conditions
None	None
None	None
None	None
