# West Park Elementary School

Umat\_sch06A

## FEMA 154 Rapid Visual Screening Score Card

Rapid Visual Screening - Senate Bill #2 - Seismic Needs Assessment  
Oregon Department of Geology and Mineral Industries

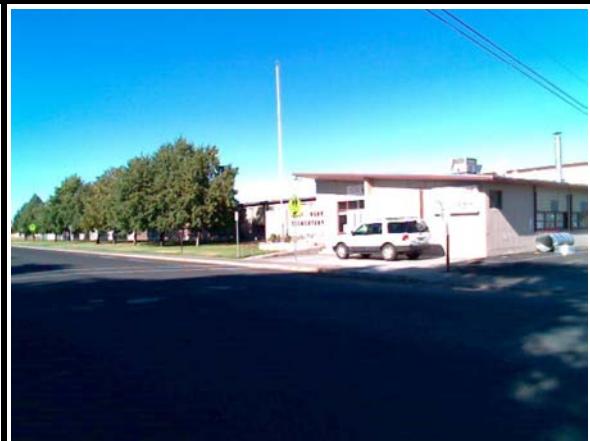
Type	Basic Score	Vert Irreg	Plan Irreg	Pre-Code	Post-Bench	Soil C	Soil D	Soil E	RVS Score
Primary	C2	3.6	-2	-0.5	0	0	0	-1.2	0	-0.1
Secondary		0	0	0	0	0	0	0	0	0
Tertiary		0	0	0	0	0	0	0	0	0

Final Type	Final Score
C2	-0.1

Very High (100%)

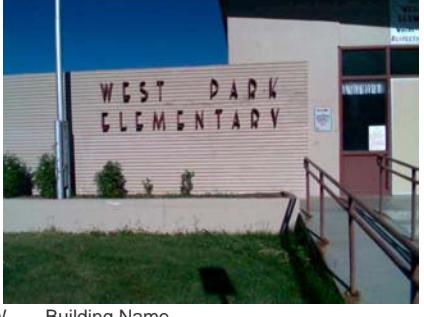
W Building Name	S Elevation View	NE Elevation View

Enrollment 406	Year Built (Field Verified) 1950	Year Built (Alt. Source) 1950	Est. Decade Built 1950
Total Area (square ft) 49875	Number of Stories 1	Basement	Pounding Potential No
Plan Irregularities Reentrant Corners: Other None None		Vertical Irregularities Steps in Elevation View: 2 to 3 Changes None None	
Falling Hazards None None None		Poor Conditions None None None

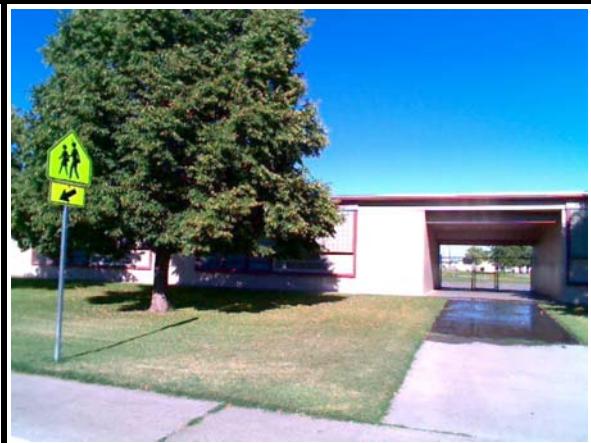
Type	Basic Score	Vert Irreg	Plan Irreg	Pre-Code	Post-Bench	Soil C	Soil D	Soil E	RVS Score
Primary	C2	3.6	0	0	0	0	0	-1.2	0	2.4
Secondary		0	0	0	0	0	0	0	0	0
Tertiary		0	0	0	0	0	0	0	0	0

Final Type	Final Score
C2	2.4

Low (<1%)

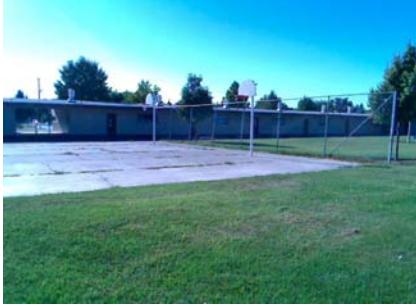
E Elevation View

Enrollment 406	Year Built (Field Verified) 1950	Year Built (Alt. Source) 1950	Est. Decade Built 1950
Total Area (square ft) 49875	Number of Stories 1	Basement	Pounding Potential No
Plan Irregularities None None None		Vertical Irregularities None None None	
Falling Hazards None None None		Poor Conditions None None None

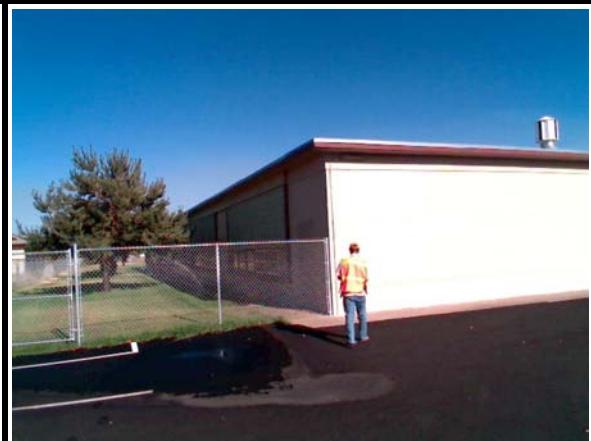
Type	Basic Score	Vert Irreg	Plan Irreg	Pre-Code	Post-Bench	Soil C	Soil D	Soil E	RVS Score
Primary	C2	3.6	0	0	0	0	0	-1.2	0	2.4
Secondary		0	0	0	0	0	0	0	0	0
Tertiary		0	0	0	0	0	0	0	0	0

Final Type	Final Score
C2	2.4

Low (<1%)

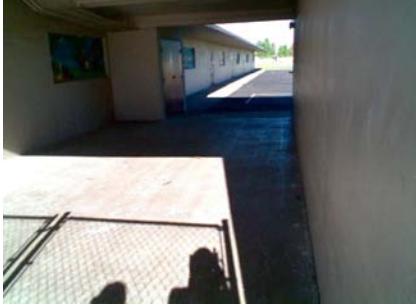
SW Elevation View

Enrollment 406	Year Built (Field Verified) 1950	Year Built (Alt. Source) 1950	Est. Decade Built 1950
Total Area (square ft) 49875	Number of Stories 1	Basement	Pounding Potential No
Plan Irregularities None None None		Vertical Irregularities None None None	
Falling Hazards None None None		Poor Conditions None None None

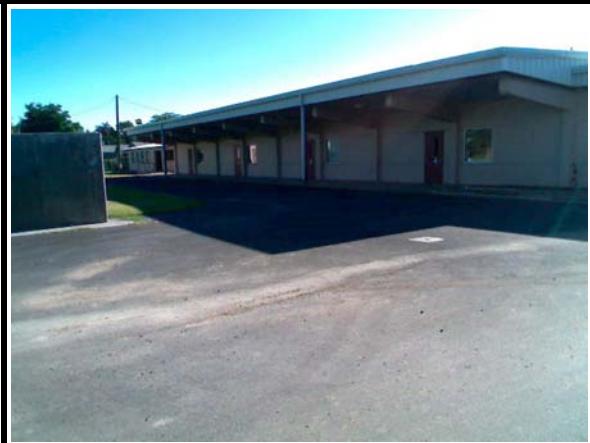
Type	Basic Score	Vert Irreg	Plan Irreg	Pre-Code	Post-Bench	Soil C	Soil D	Soil E	RVS Score
Primary	C2	3.6	0	-0.5	0	0	0	-1.2	0	1.9
Secondary	PC1	3.2	0	-0.5	0	0	0	-1	0	1.7
Tertiary		0	0	0	0	0	0	0	0	0

Final Type	Final Score
PC1	1.7

Moderate (>1%)

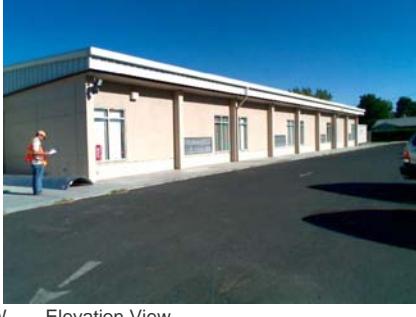
W Elevation View

Enrollment 406	Year Built (Field Verified) 1950	Year Built (Alt. Source) 1950	Est. Decade Built 1950
Total Area (square ft) 49875	Number of Stories 1	Basement	Pounding Potential No
Plan Irregularities Reentrant Corners: L Shaped None None		Vertical Irregularities None None None	
Falling Hazards None None None		Poor Conditions None None None
