McKay Creek Elementary School

Umat_sch24A

Rapid Visual Screening - Senate Bill #2 - Seismic Needs Assessment
Oregon Department of Geology and Mineral Industries

Umat_sch24B

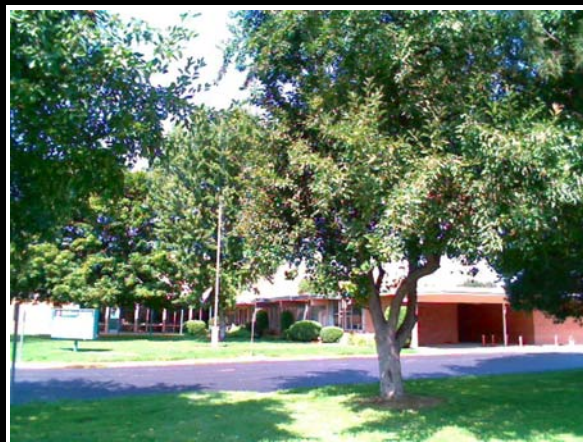
Building Type		County	
School		Umatilla	
Street			
1539 Sw 44th St			
City	State	Zip	
Pendleton	OR	97801	
Latitude		Longitude	
45.64604		118.82535	
Tracking Code		Inspection Date	
RVS in 2006		8/15/2006

Type	Basic Score	Vert Irreg	Plan Irreg	Pre-Code	Post-Bench	Soil C	Soil D	Soil E	RVS Score
Primary	W2	4.8	-3	-0.5	0	0	-0.8	0	0	0.5
Secondary		0	0	0	0	0	0	0	0	0
Tertiary		0	0	0	0	0	0	0	0	0

High (>10%)

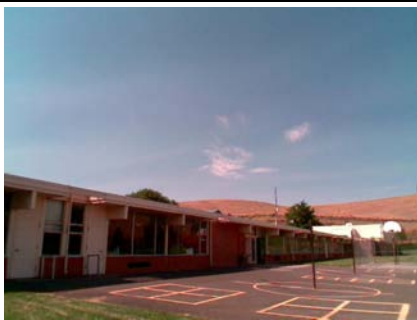
N Elevation View

Plan Irregularities	Vertical Irregularities
Reentrant Corners: Other (Adjacent Build/Entity)	Steps in Elevation View: Single Change (Adjacent Building/Entity)
Reentrant Corners: L Shaped	None
None	None

Falling Hazards	Poor Conditions
None	None
None	None
None	None

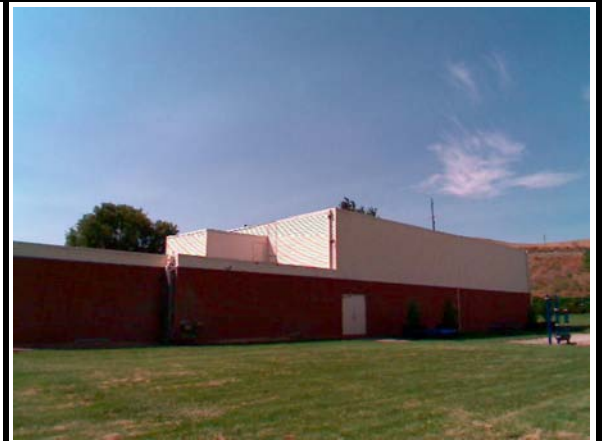
Building Type		County	
School		Umatilla	
Street			
1539 Sw 44th St			
City		State	Zip
Pendleton		OR	97801
Latitude		Longitude	
45.64596		118.82606	
Tracking Code		Inspection Date	
RVS in 2006		8/15/2006

Type	Basic Score	Vert Irreg	Plan Irreg	Pre-Code	Post-Bench	Soil C	Soil D	Soil E	RVS Score
Primary	W2	4.8	-3	-0.5	0	1.6	-0.8	0	0	2.1
Secondary		0	0	0	0	0	0	0	0	0
Tertiary		0	0	0	0	0	0	0	0	0

Low (<1%)
