Union Emergency Services - Fire

Unio_fir07A

FEMA 154 Rapid Visual Screening Score Card

Rapid Visual Screening - Senate Bill #2 - Seismic Needs Assessment
Oregon Department of Geology and Mineral Industries

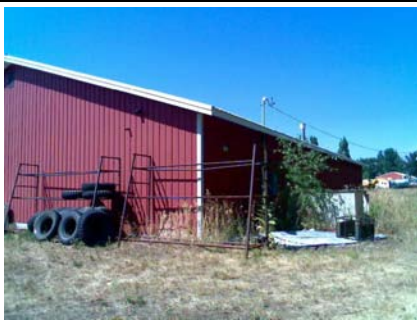
NW Elevation View

Plan Irregularities	Vertical Irregularities
Torsion: Eccentric Stiffness	None
None	None
None	None

Falling Hazards	Poor Conditions
None	None
None	None
None	None
